Memorandum

Date: 2004-05-21

Subject: Problems with PLL Attenuators in Production LO

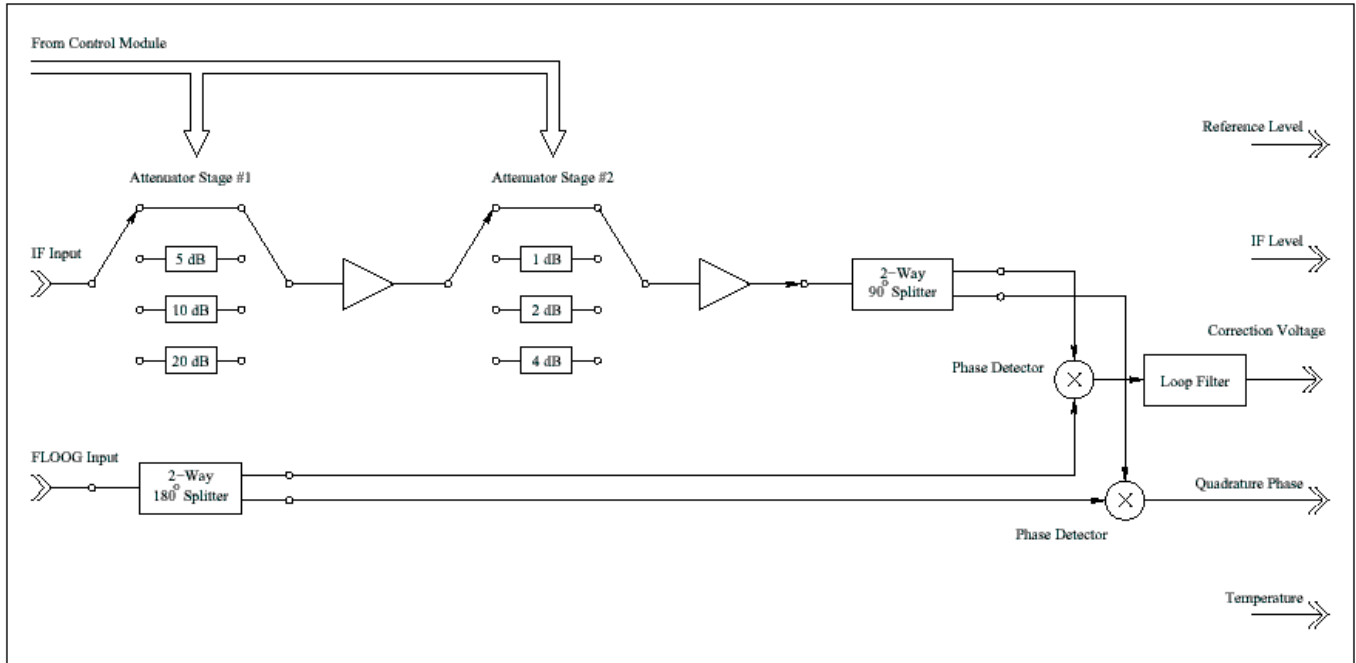
Figure 1: Block Diagram of PLL Circuit

Figure 1 is the block diagram of the PLL circuit¹ in the Warm Cartridge Assembly. To independently test the PLL assembly, K. Saini recommended injecting a 30 MHz, -20 dBm signal into the "IF Input" port shown in the figure and commanding the attenuators with Christian's LabVIEW program while examining two responses:

1. The read-back attenuator value, which apparently is stored in the AMBSI board on the temporary LO M&C chassis, and
2. The detected PLL IF power, which is from a crystal detector in the PLL box located after the second amplifier in Figure 1 but not drawn in that figure.

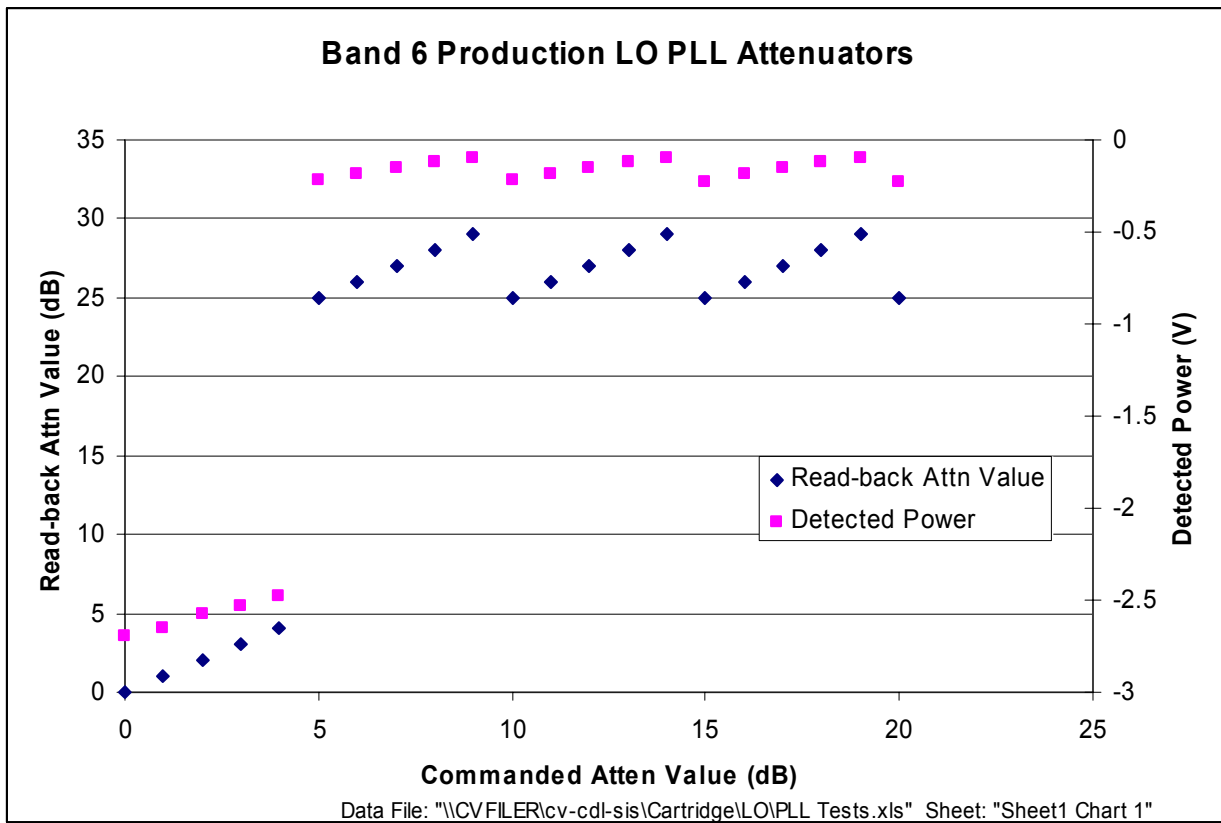
Figure 2: Read-back vs Commanded Attenuator Values and Detected Power

Attempts last week to phase lock the production LO failed and the problem was traced to the inability to correctly set the attenuators in the PLL box in the Warm Cartridge Assembly (WCA). When the commanded attenuator value is changed from 4 dB to 5 dB, the read-back attenuator value jumps from 4 dB to 25 dB. The detected power in this case is consistent with the attenuator actually being set to 25 dB. The read-back attenuator value continues increasing by increments 20 dB greater than the commanded value until the commanded value changes from 9 dB to 10 dB when the read-back value jumps from 29 dB to 25 dB. The read-back vs. commanded attenuator values are graphed in Figure 2.

Figure 2 is a graph of both the read-back attenuator value and the detected power vs. the commanded attenuator value. This graph shows how the read-back attenuator value jumps at 5 dB boundaries of the commanded attenuator value and how the detected voltage is consistent with the read-back attenuator value.

1. Does the LabVIEW software convert the commanded attenuator value to the correct string to send over the CAN bus?
2. Does the AMBSI firmware in the temporary LO M&C chassis decode the CAN string into the proper format for sending to the M&C box in the WCA?
3. Does the M&C box in the WCA correctly decode the attenuator command string to set the proper attenuator lines for the PLL box?

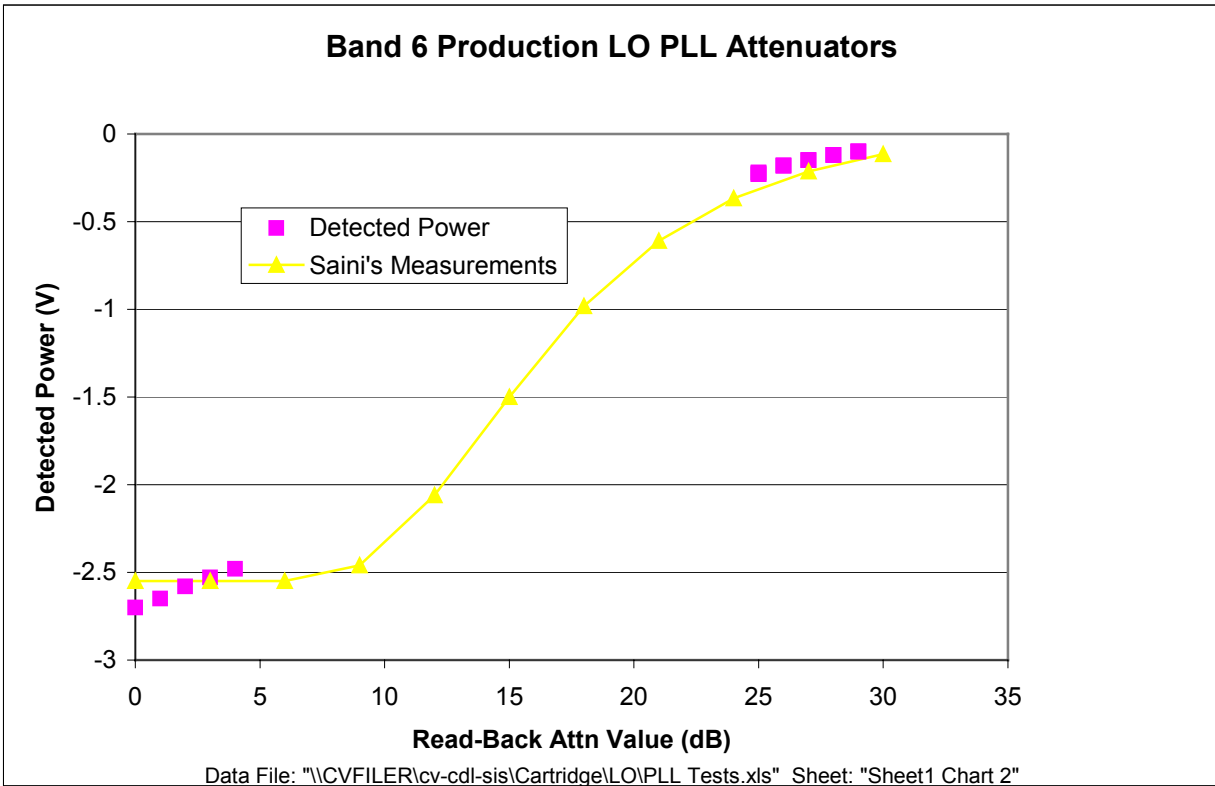
Figure 3: Detected Power vs. Read-Back Attenuator Value

Further evidence that the PLL attenuators are being set according to the read-back attenuator values is shown in Figure 3. This graphs the detected power as a function of the read-back attenuator value superimposed on data taken by K. Saini. Saini actually measured detected power vs. input power level, but his data was converted to an equivalent attenuation and plotted on this graph.
