**To:** File

**Date:** 2010-12-08

**Subject:** Spikes Found in LO Waveguide Integrity Data for Band 6 Cold Cartridges

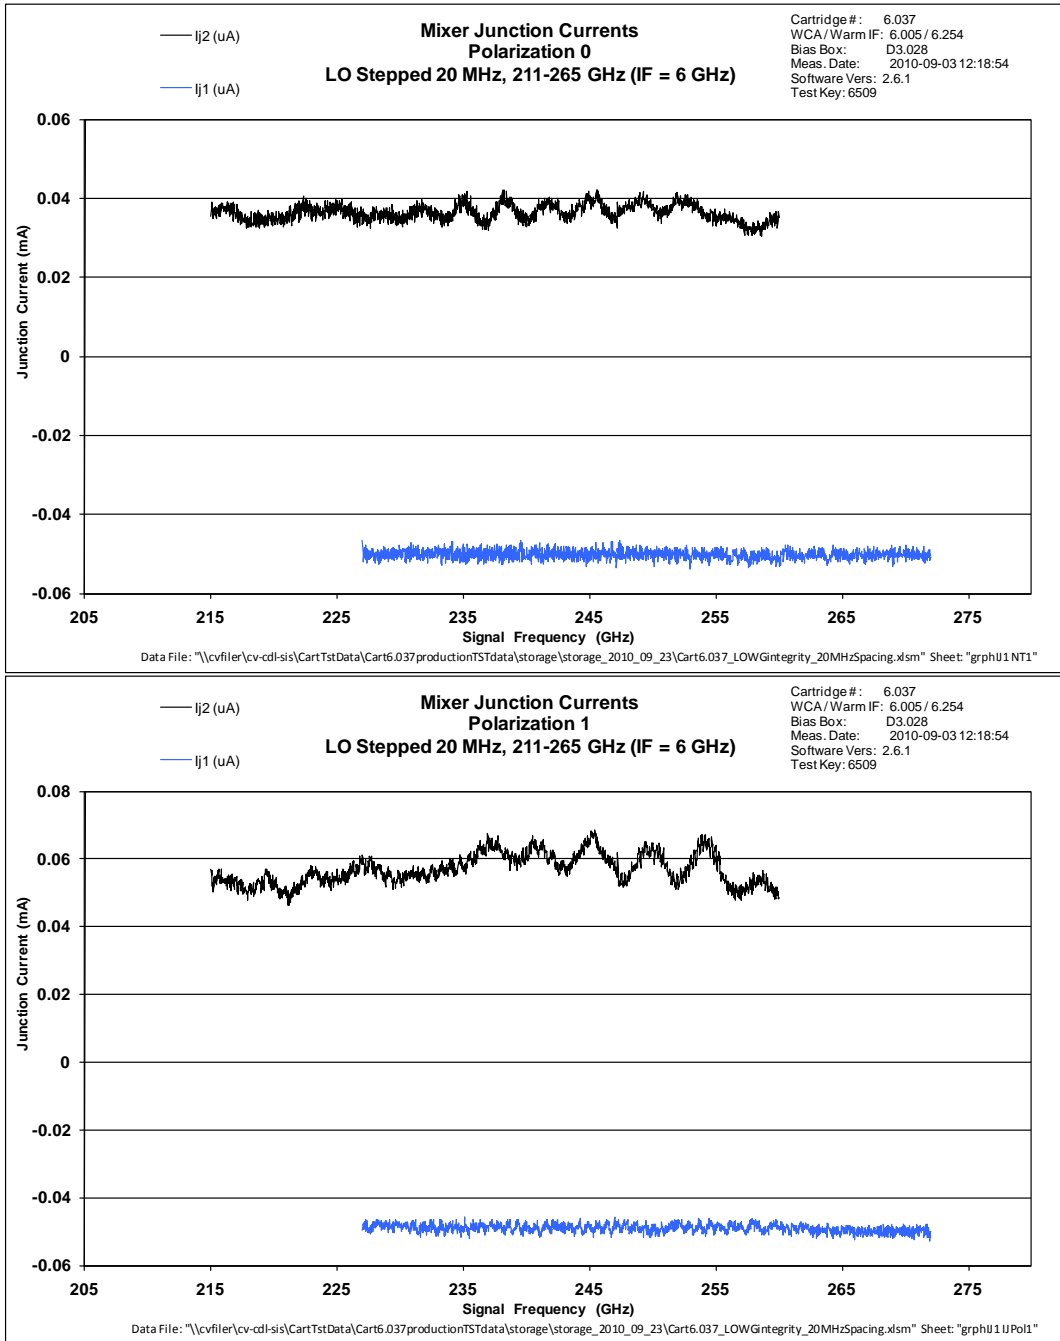
Figure 10: Cart 6.037, Junction Currents for [Figure 9](#), WCA 6.005, CTS-1

A new batch of overmoded waveguide showed spikes during VNA measurements in late summer, so LO WG integrity frequency spacing was reduced from the nominal 100 MHz to 20 MHz to search for those spikes in B6.037. [Figure 9](#) shows the same sharp spikes as found recently, but at that time the spikes were thought to not originate in the LO WG because mixer pump currents show no spikes ([Figure 10](#)). Additional tests showed B6.037 missed optics specs, so the entire optics system and mixers were replaced, and the spikes disappeared, as shown in [Figure 11](#). Optics problems continued, so the OMT was replaced for this cartridge and the LO WG integrity continued to show no spikes ([Figure 12](#)).

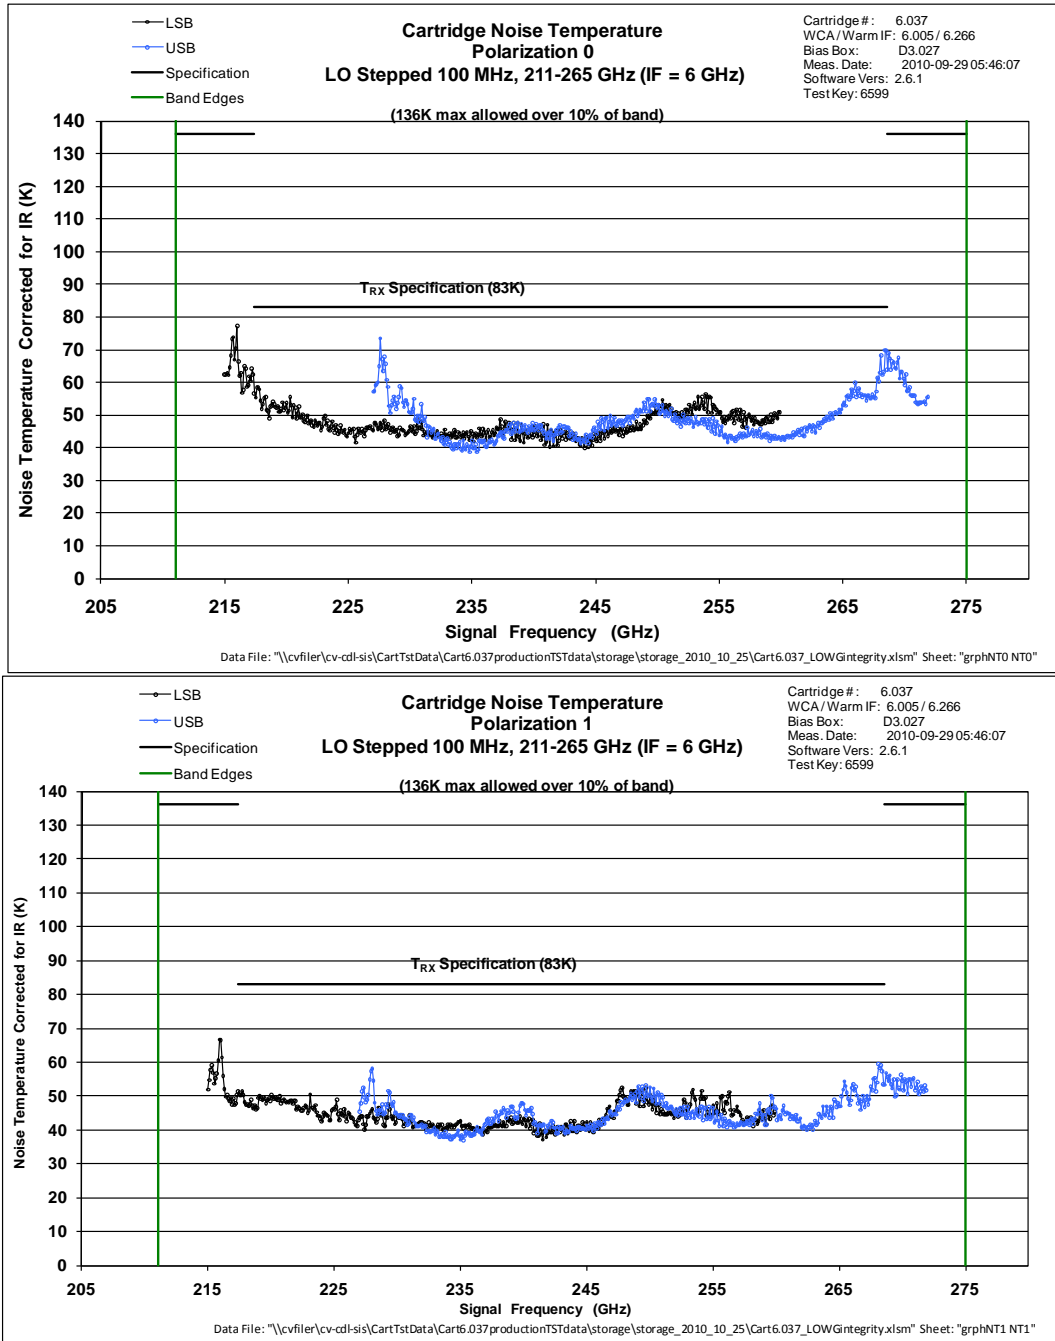
Figure 11: Cart 6.037, Replaced A-frame, mirrors, and both mixers, WCA 6.005, CTS-2

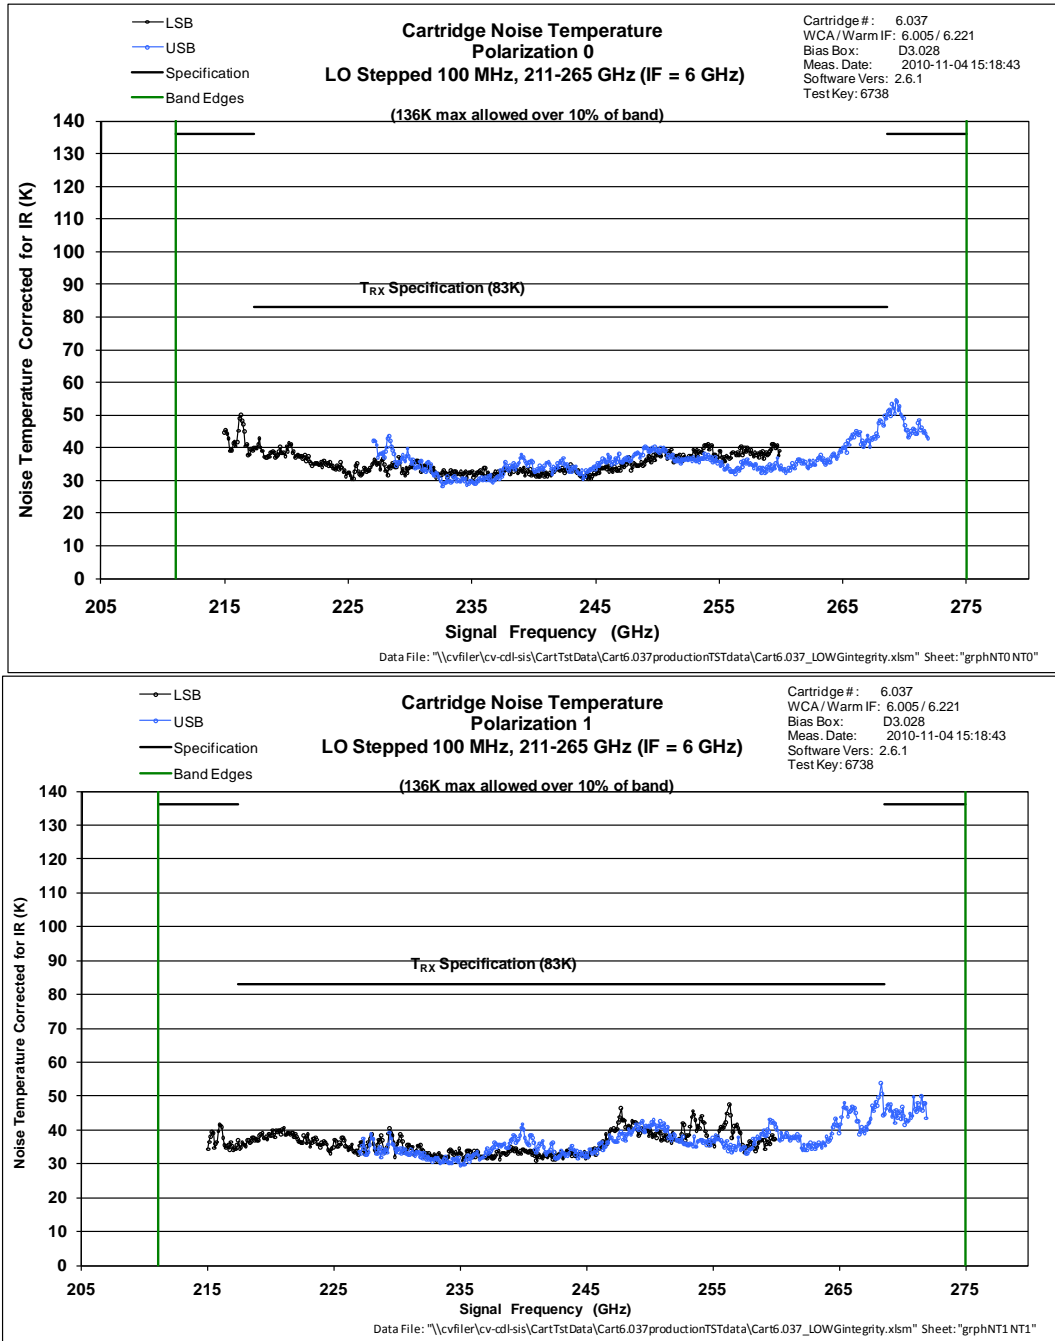
Figure 12: Cart 6.037, Changed OMT, WCA 6.005, CTS-1

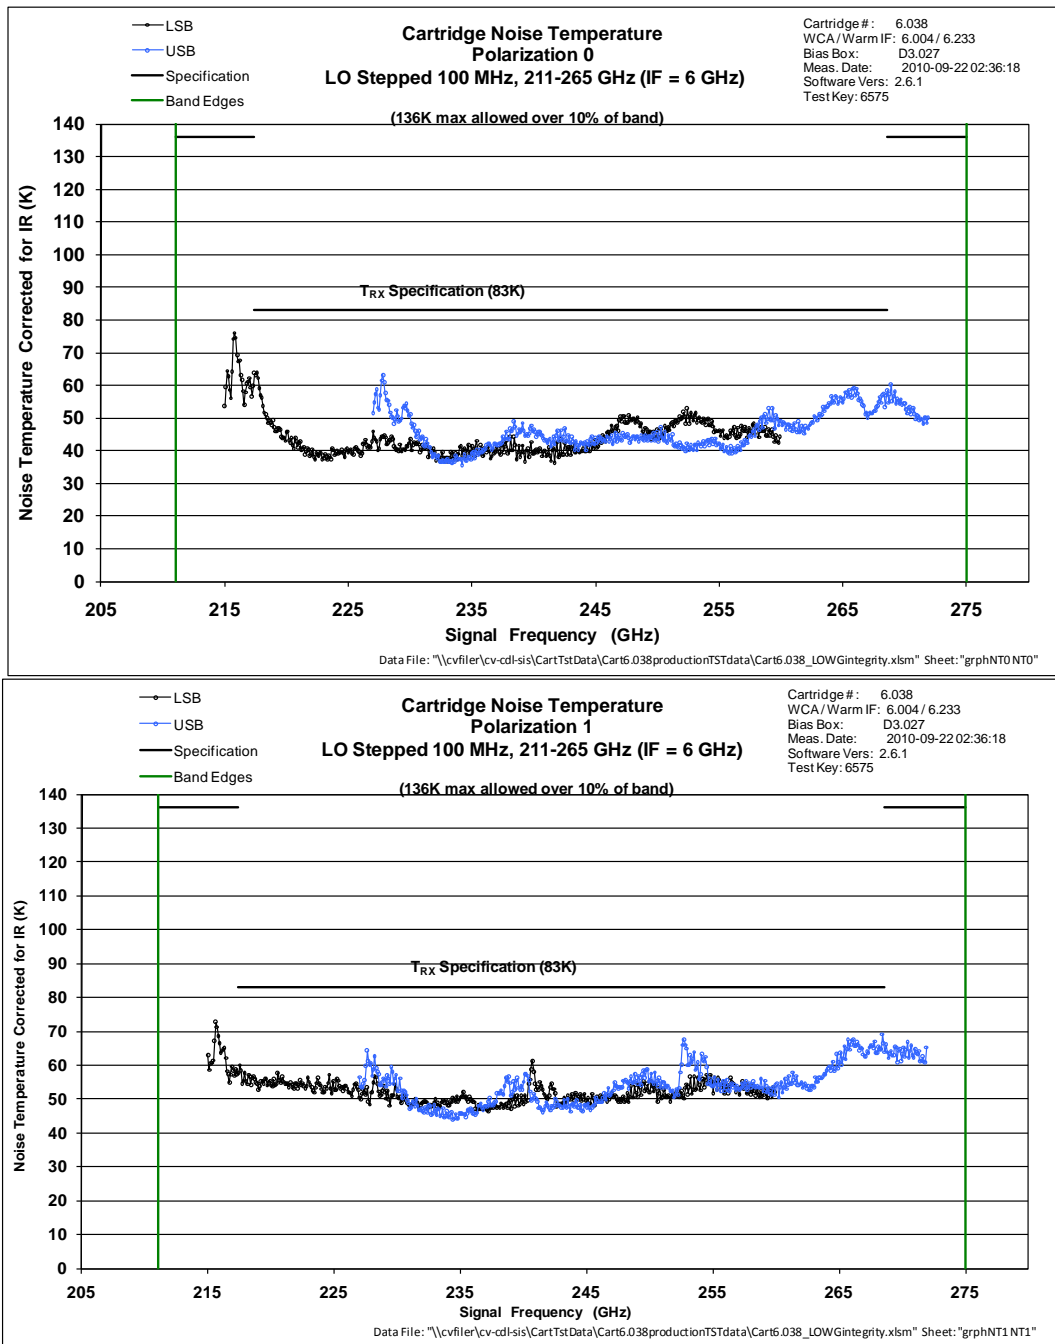
High noise in B6.038 ([Figure 13](#)) at the bottom of the band was thought to originate from WCA6-004, and we approved it based on that assumption, but notice the now-suspect spikes in Pol 1.

Figure 13: Cart 6.038, WCA 6.004, CTS-2

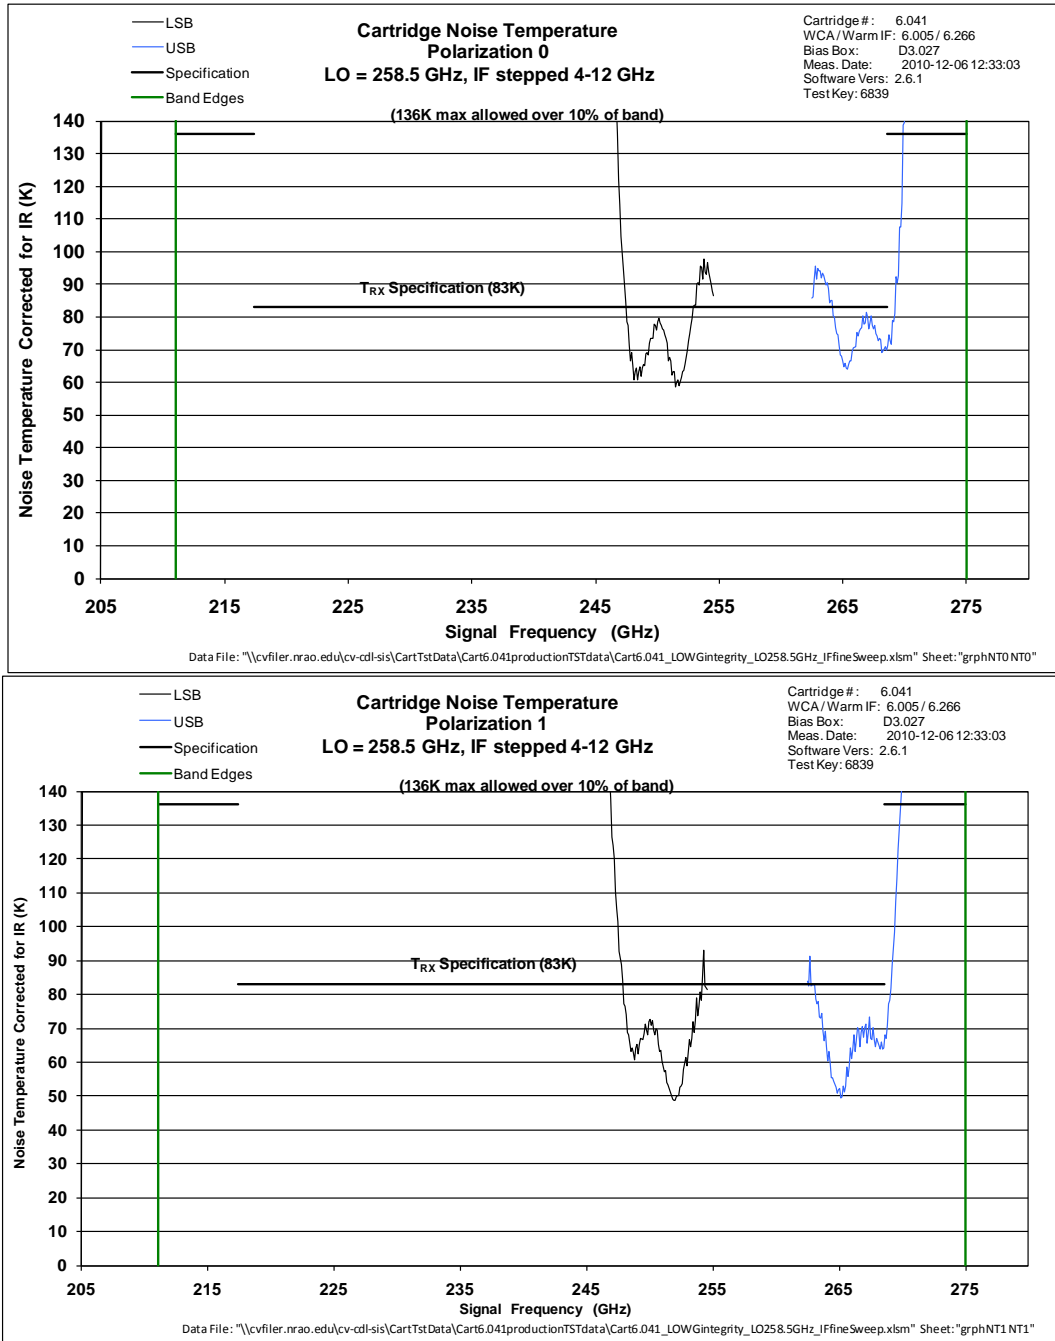
Fixing the LO and stepping the IF in 100 MHz steps shows spikes ([Figure 19](#) and [Figure 21](#)) at the same IF (4.2 GHz). This data should be compared to [Figure 16](#) which shows the normal LO WG integrity data with 100 MHz LO steps.

Figure 19: Fine IF steps, LO = 258.5 GHz, otherwise same configuration as Figure 16

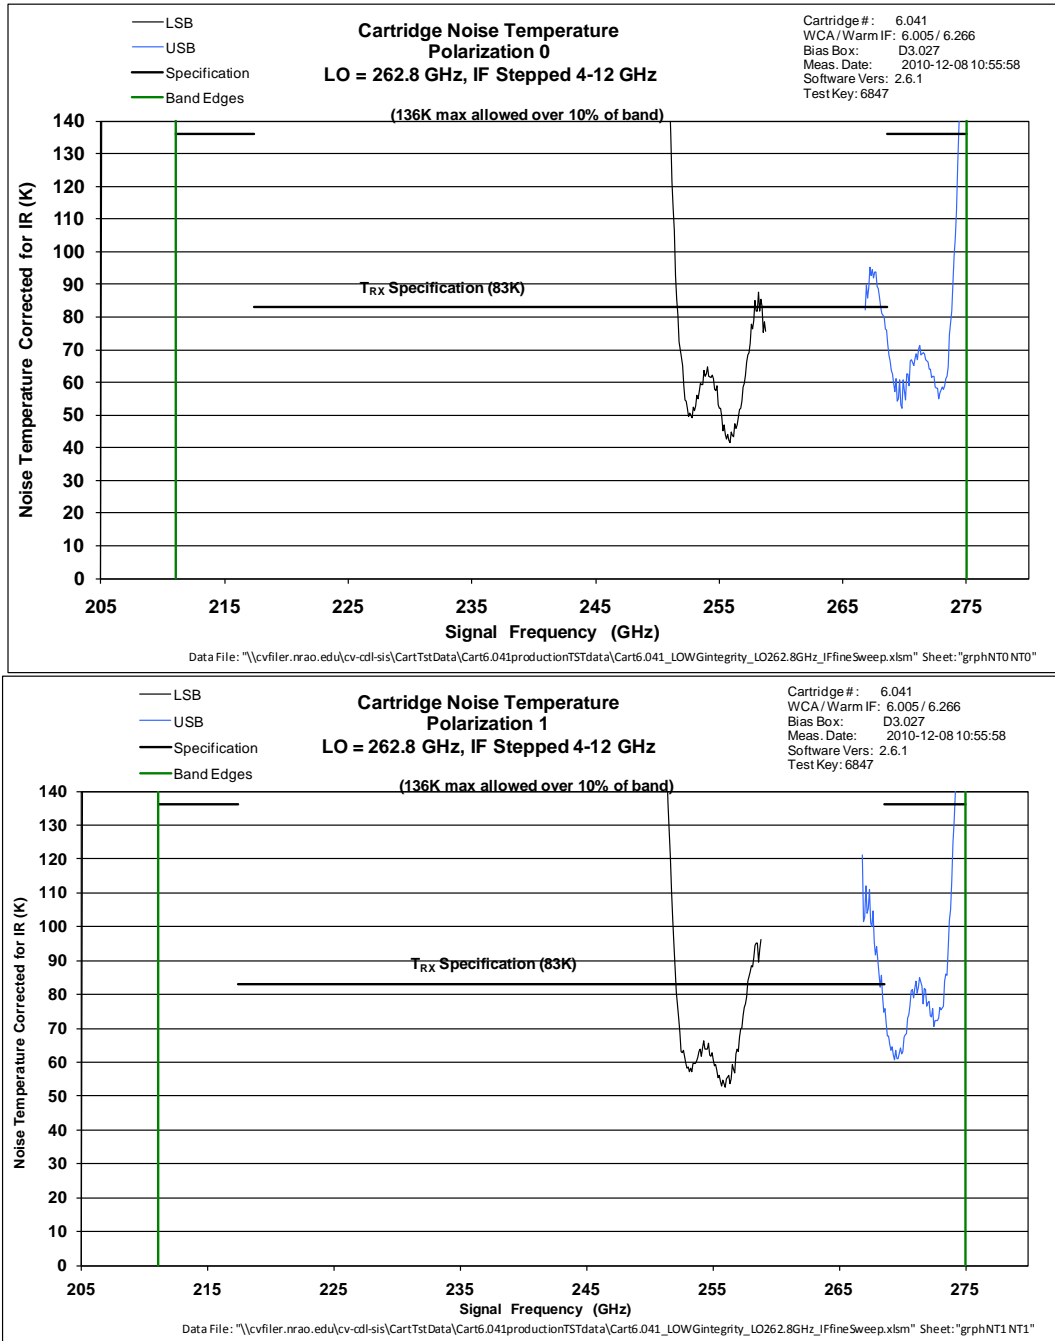
Added [Figure 18](#) showing partial LO WG integrity with increased magnet current from 25 mA to 45 mA. [Figure 20](#) was added to include the LO where the oscillations were observed using stepped IF with fixed LO= 262.8 GHz.

Figure 20: Fine IF steps, LO = 262.8 GHz, otherwise same configuration as Figure 16

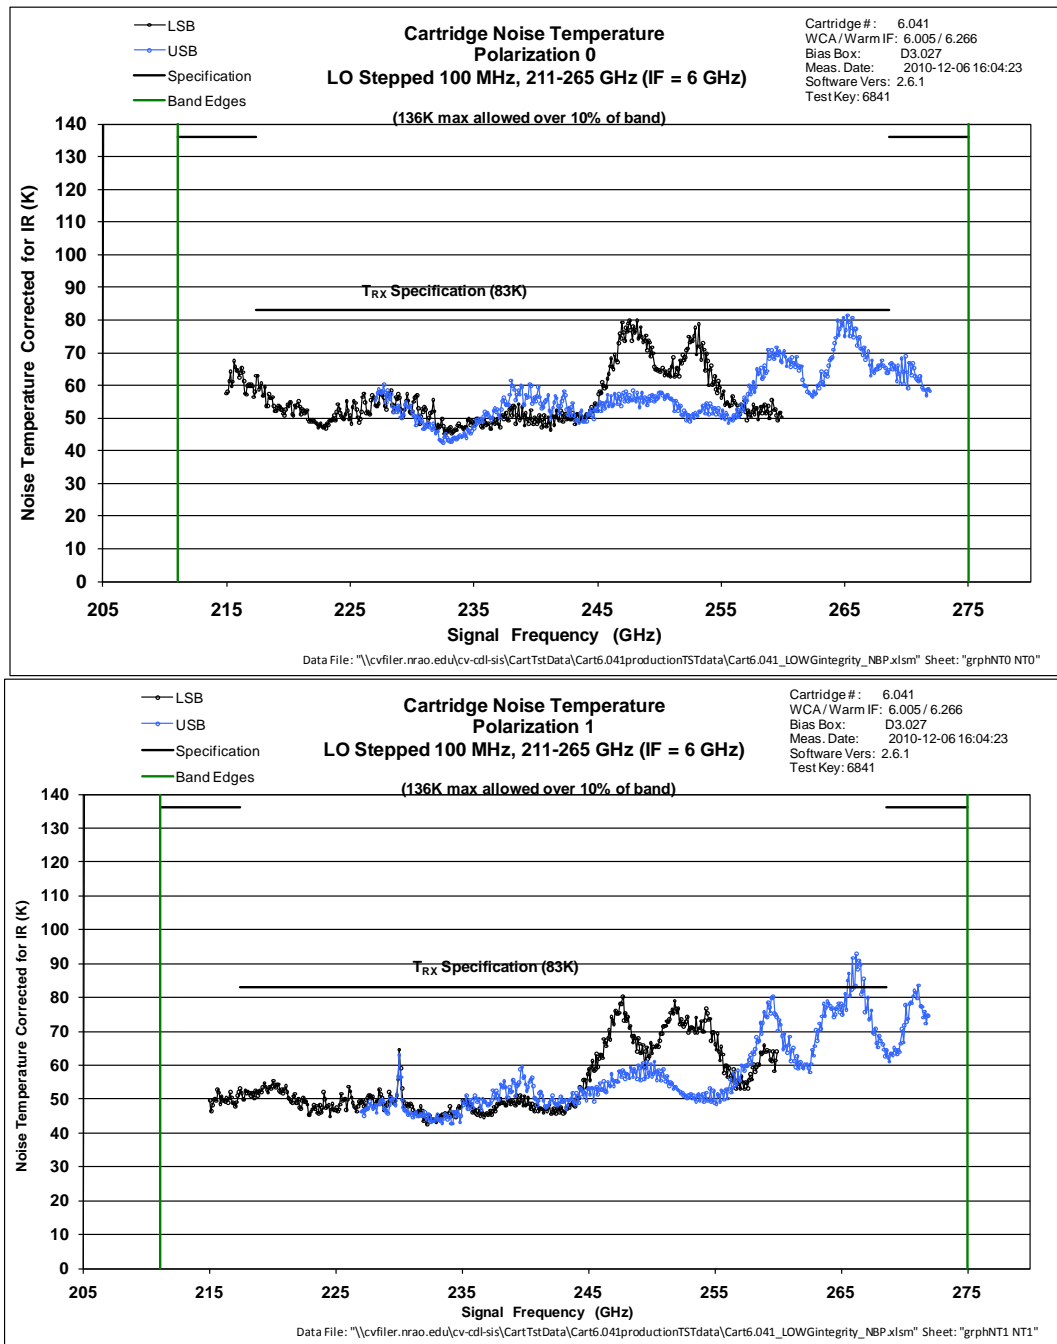
LO WG integrity was measured with nominal fixed bias of  $V_j = 8.5$  mV and  $I_j = 50$  uA ([Figure 23](#)) and comparing this to previous optimal bias measurements ([Figure 14](#)) shows that the peaks are likely still present, but now almost obscured by suspiciously high noise regions in Pol 0 and have possibly changed frequencies in Pol 1. Preamp bias for this case remains at  $V_{D1,2 \text{ and } 3} = 0.7$ V and  $I_{D1,2, \text{ and } 3} = 3$  mA which had eliminated oscillations in most cases. The bias current for nominal fixed bias shows the expected constant  $I_{j2}$  vs. frequency in [Figure 24](#) while updated [Figure 25](#) demonstrates that the actual bias tracks closely the optimal  $V_j$  and  $I_{j2}$  values measured in the mixer test system.

Figure 23: B6.041 with nominal fixed mixer bias, compared to optimal bias in [Figure 16](#) and [Figure 14](#)

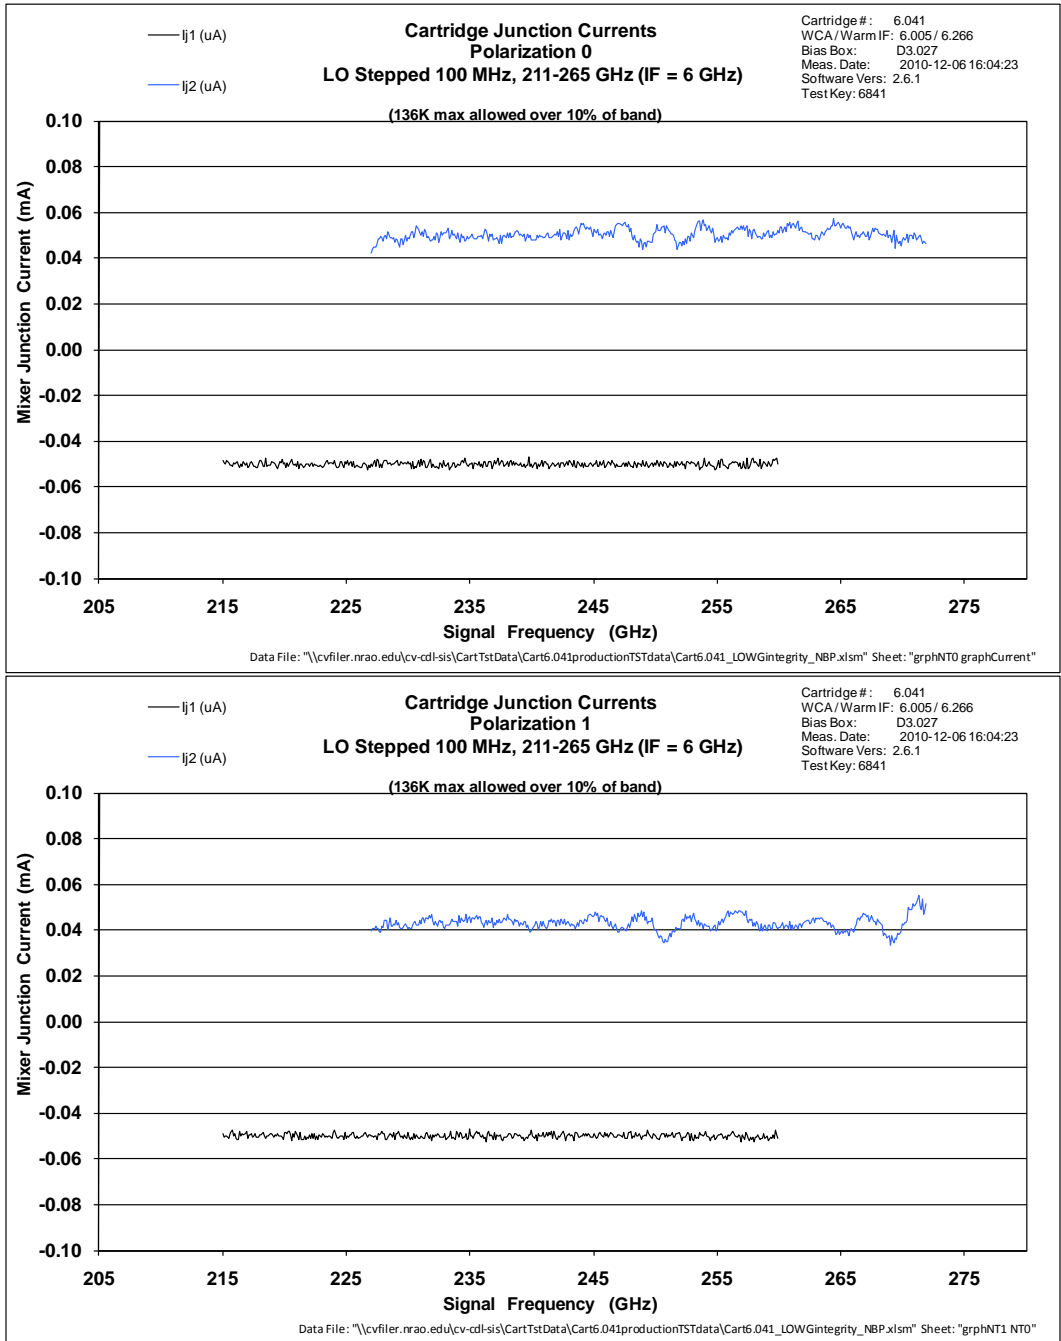
Figure 24: B6.041 with nominal bias, compared to optimal bias in [Figure 25](#)

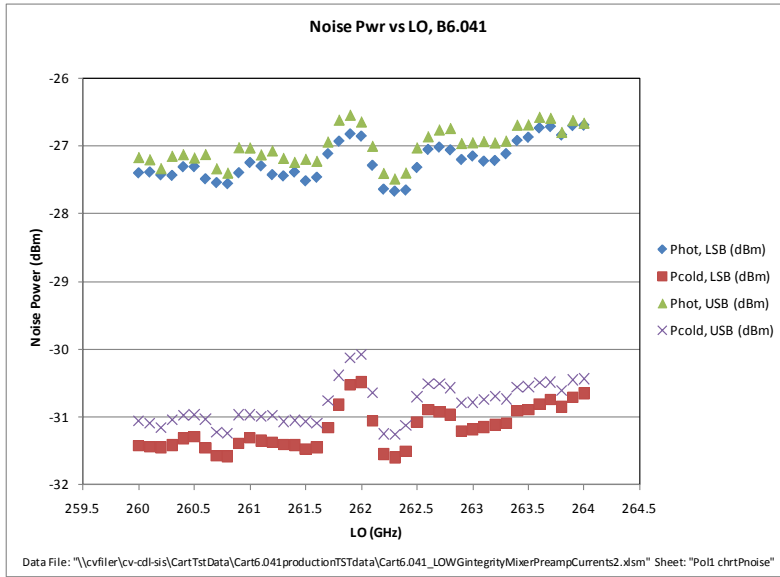
Figure 26: Cart 6.041, Pol 1, Noise Powers Near Spike (From 2010-12-02 09:12 Data)

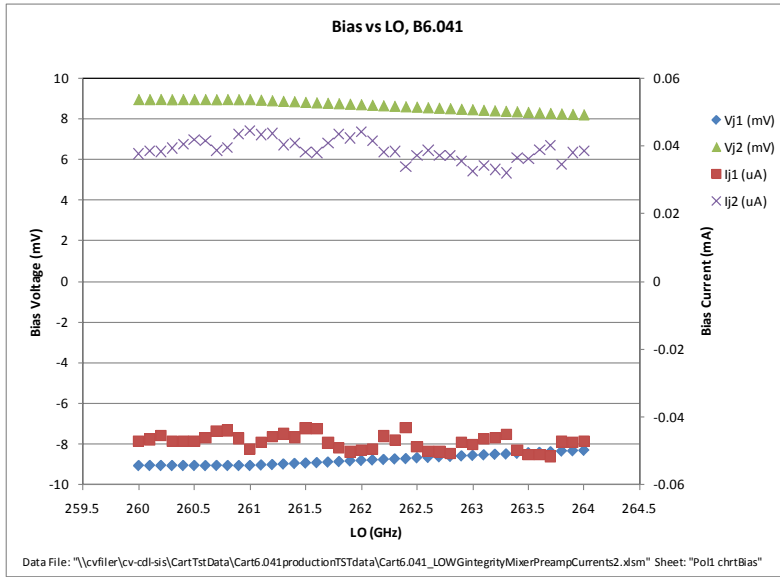
Figure 28: Cart 6.041, Pol 1, Junction Bias Near Spike (From 2010-12-02 09:12 Data)

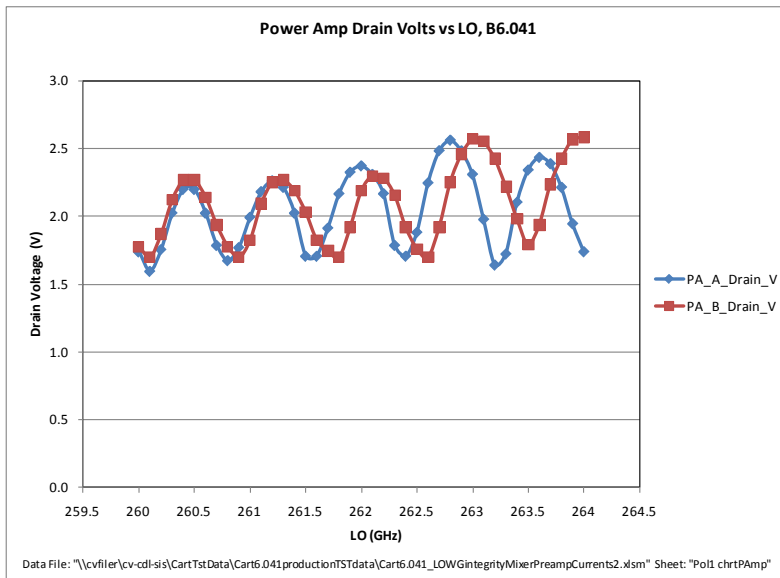
Figure 29: Cart 6.041, Pol 1, Power Amp Volts Near Spike (From 2010-12-02 09:12 Data)

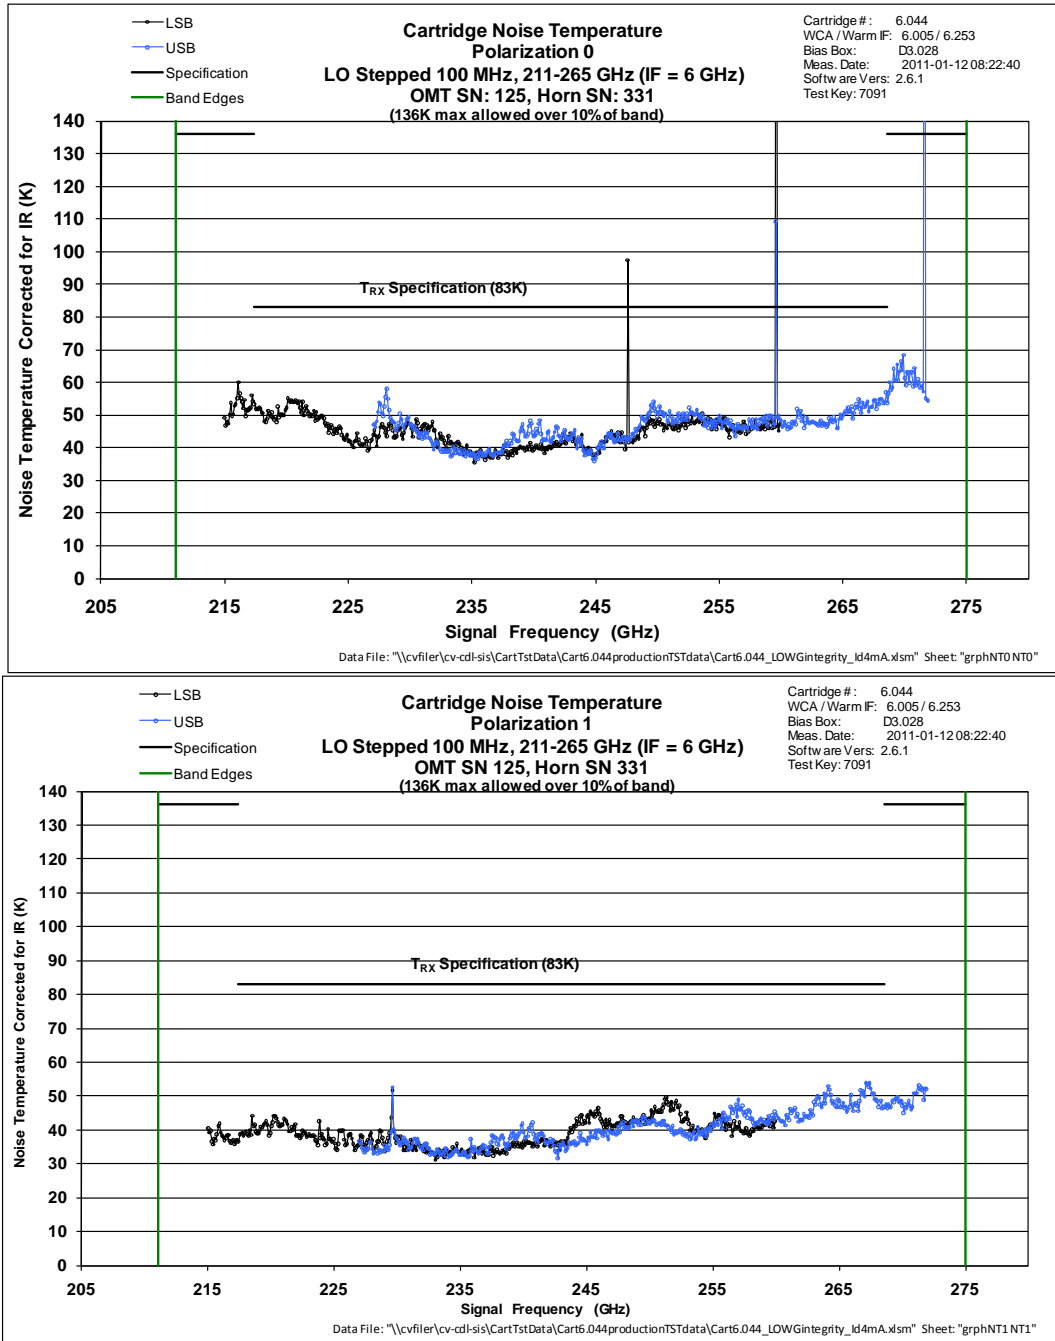
Figure 31: B6.044 Tr vs. RF, with OMT SN 125, Horn SN 331

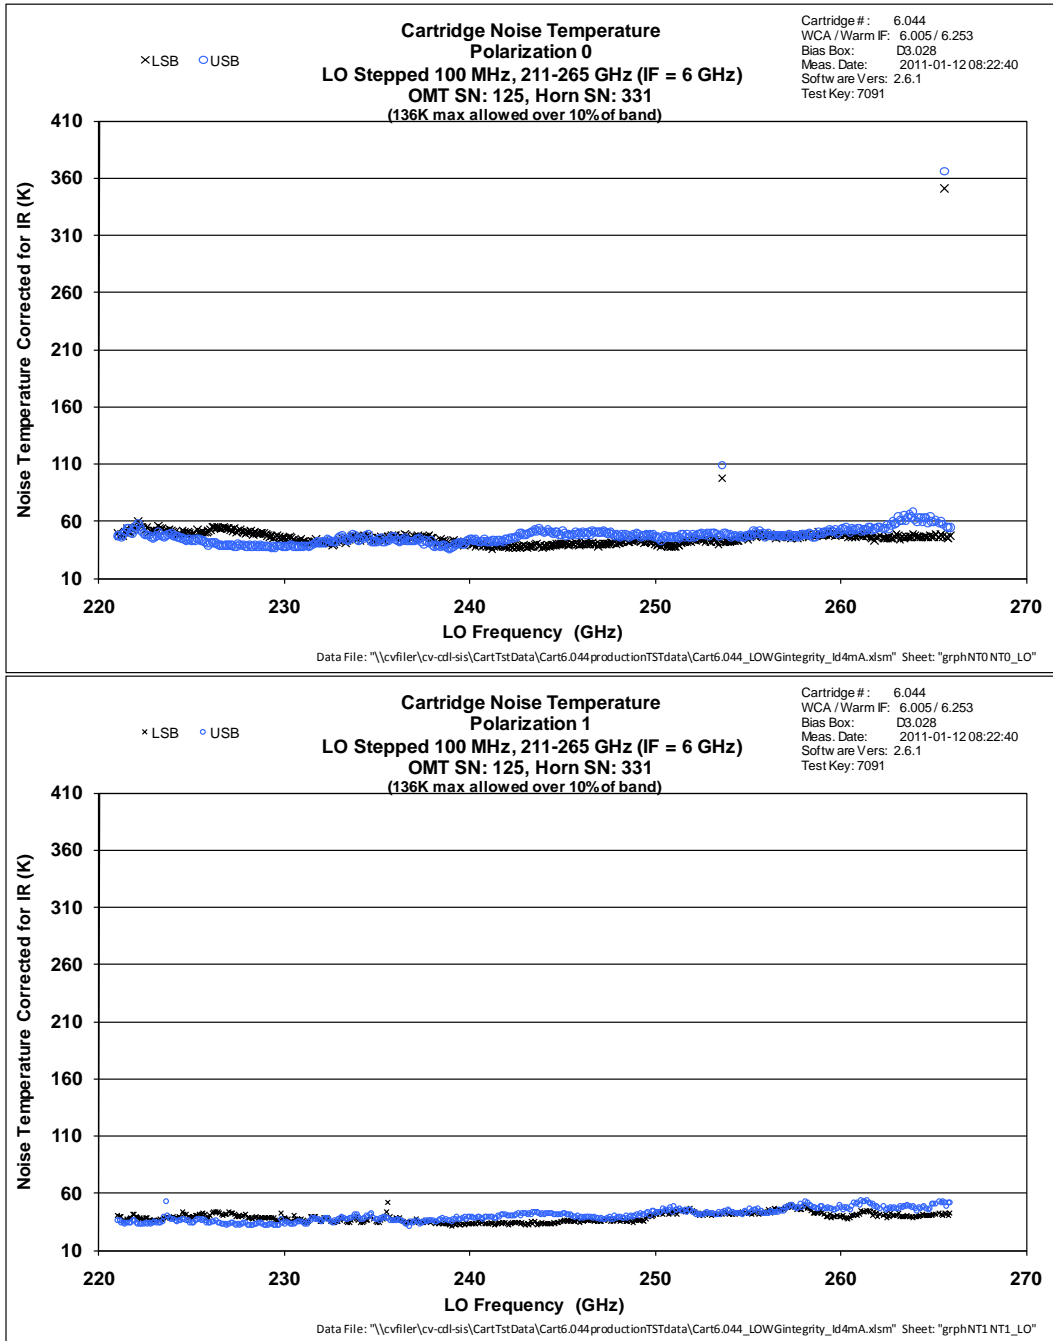
Figure 32: B6.044 Tr vs. LO Freq, with OMT SN 125, Horn SN 331

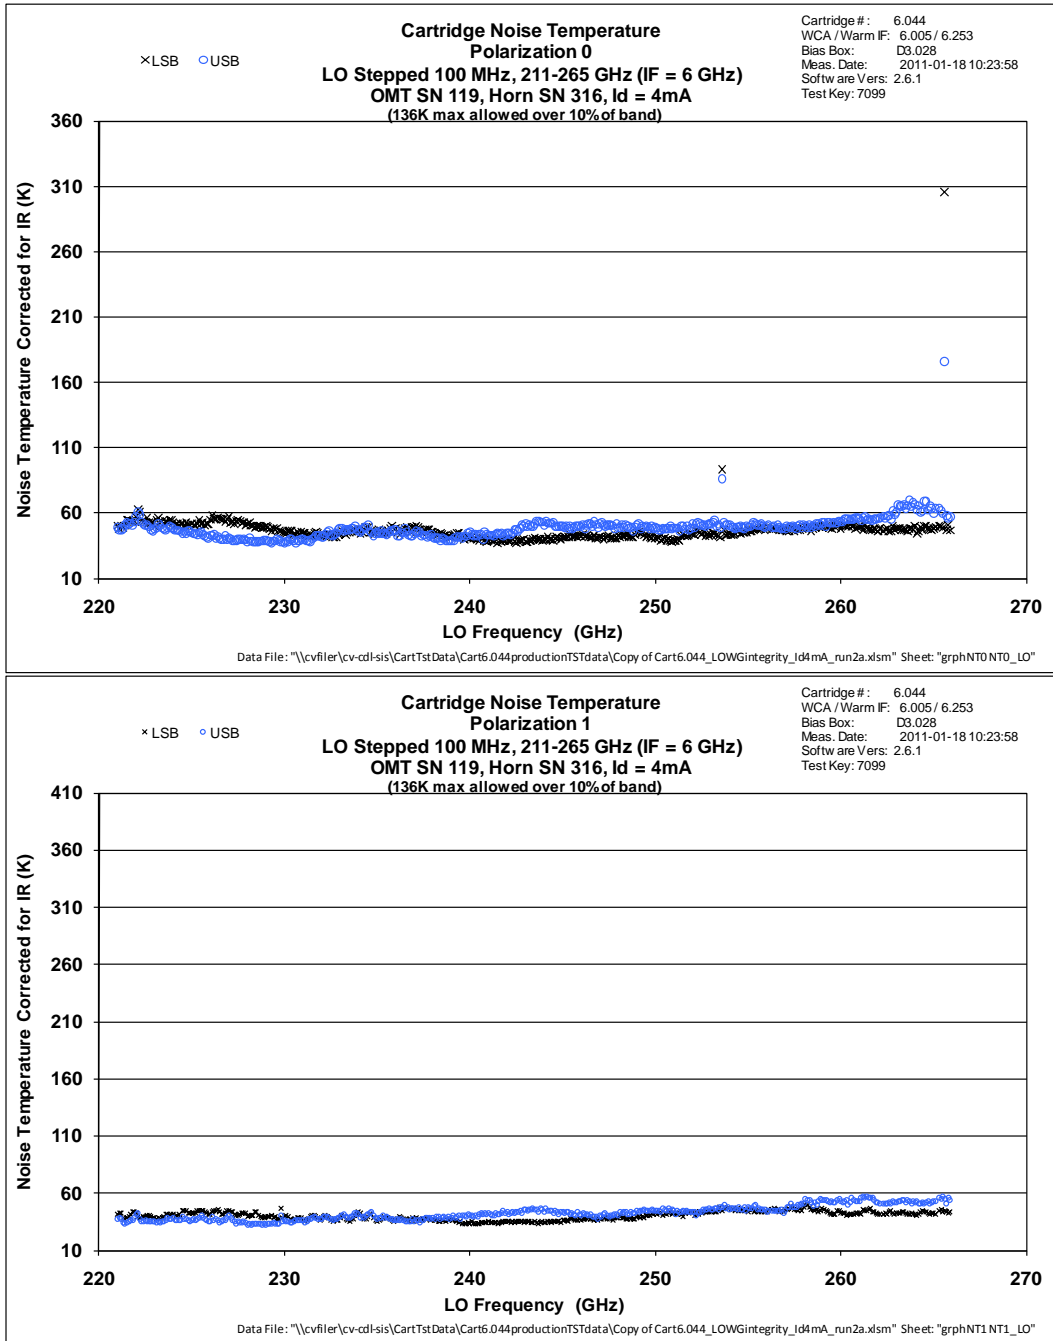
Figure 34: B6.044 Tr vs. LO Freq, with OMT SN 119, Horn SN 316

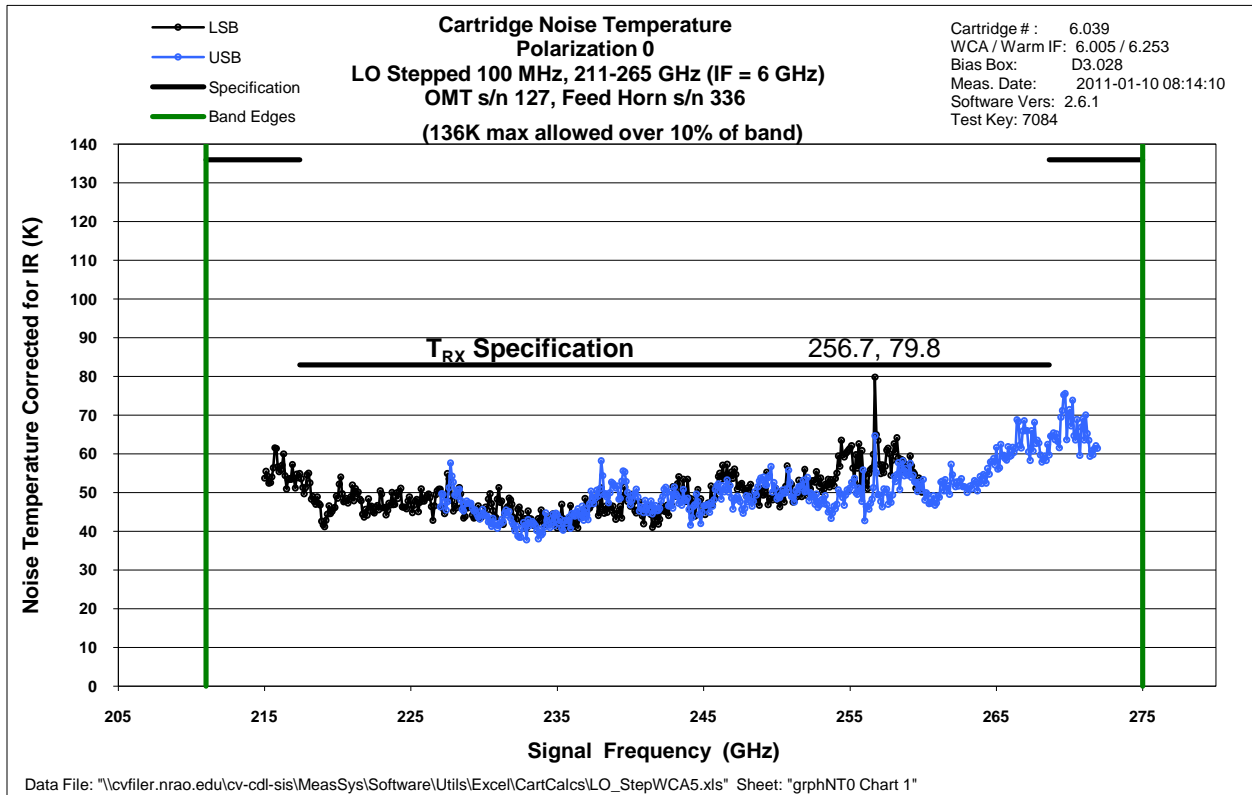
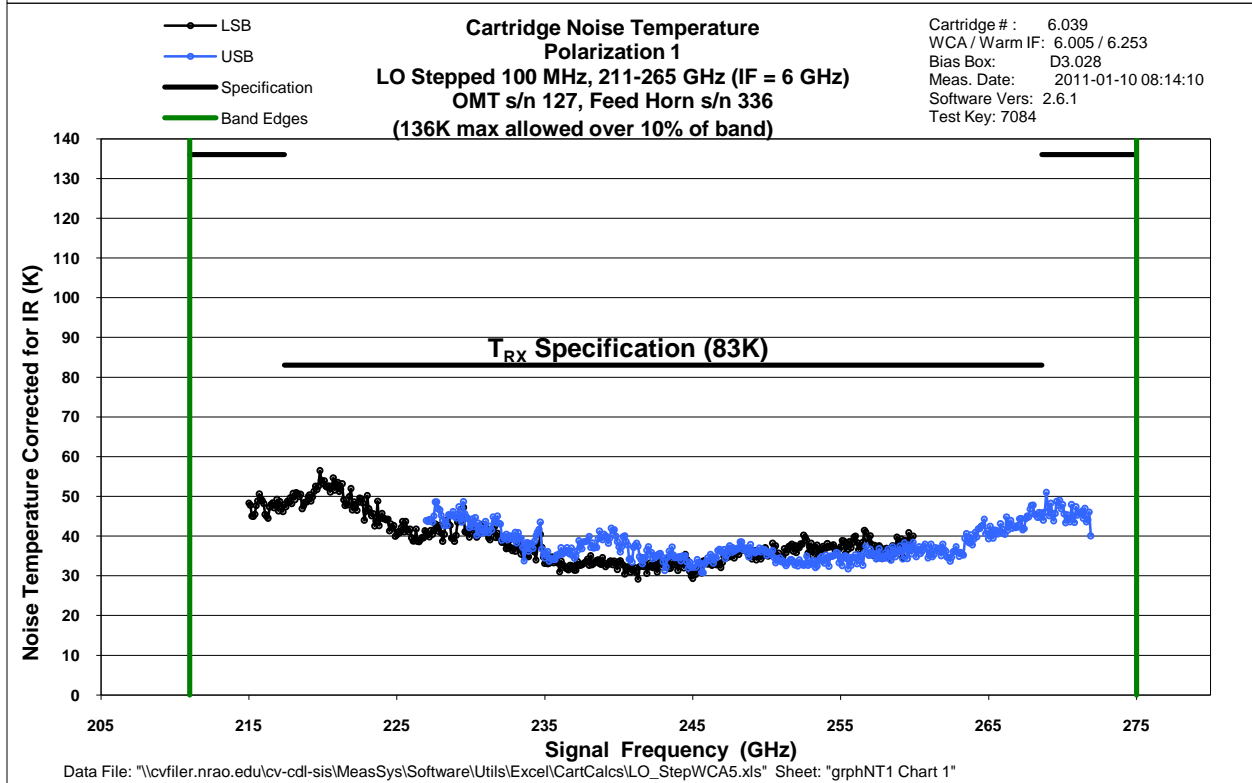
Figure 42: Tr vs RF for OMT SN 127 with Horn SN 336
