**Atacama
Large
Millimeter
Array**

**Leak Test Results
For Band 7 300K Plate
Measured by the NRAO**

FEND-40.02.07.00-009-B-TDR

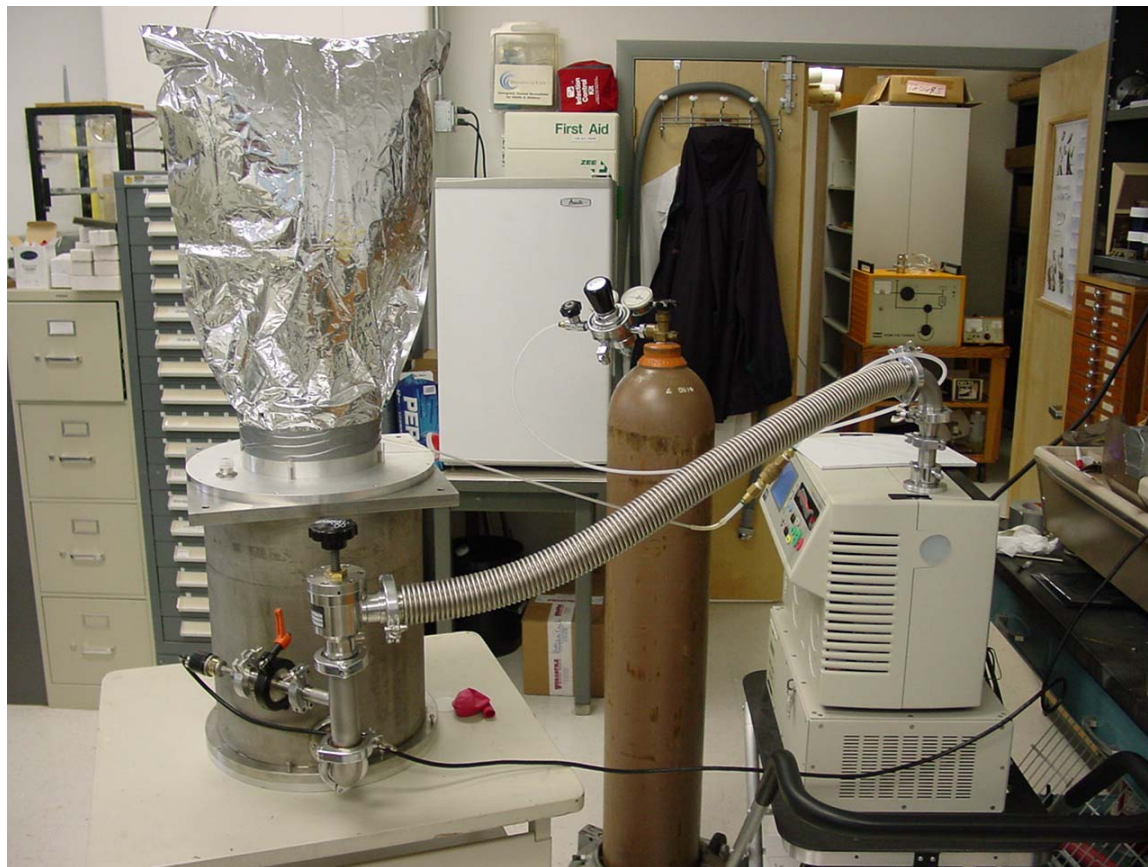
Figure 2: Helium Leak Test Setup, Side View

The vacuum side of the 300K plate was bolted to a test fixture designed by Neil Horner to measure leakage of entire Band 6 cold cartridge assemblies at the 300K plate interface (see photos, Figure 1 and Figure 2). An antistatic bag was placed over the atmospheric side of the 300K plate, filled and slightly pressurized ($\sim 1 \text{ kg/cm}^2$) by helium gas. The helium flows into the bag with a flexible hose and the bag is sealed with duct tape (see Figure 3).

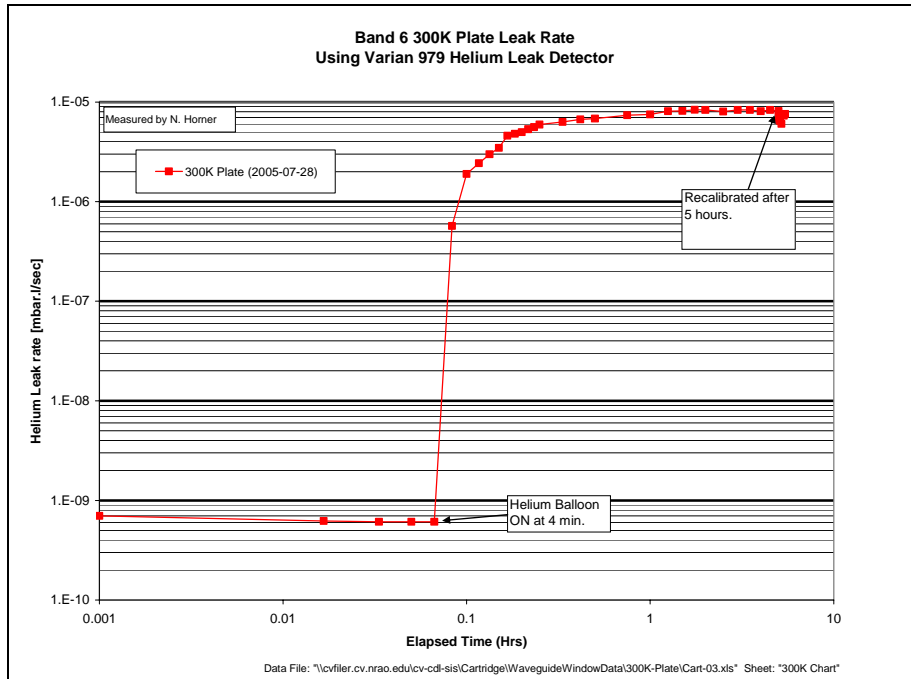
Figure 5: Helium Leak Rate for **Band 6** 300K Plate SN003

For reference, the helium leak rate of Band 6 300K plate for Cartridge SN003 is plotted in Figure 5 and is, within measurement uncertainty, the same as that measured for the Band 7 plate.

Baseline leakage rates, defined as the measured leak rate prior to introducing helium, are 3×10^{-9} mbar.l/sec for the Band 7 plate and 7×10^{-10} mbar.l/sec for the Band 6 plate. This low-level difference has an insignificant effect on the measured leak rates in the range of 10^{-6} mbar.l/sec.

It is interesting to note the difference in time required for the Band 7 and Band 6 plates to reach a constant leak rate. The Band 7 300K plate took only 3 minutes to reach the final leak rate while the Band 6 plate required 1 hour 15 minutes to reach its steady-state leak rate.
