Memorandum

Subject: Changes in Performance of OMT6-020

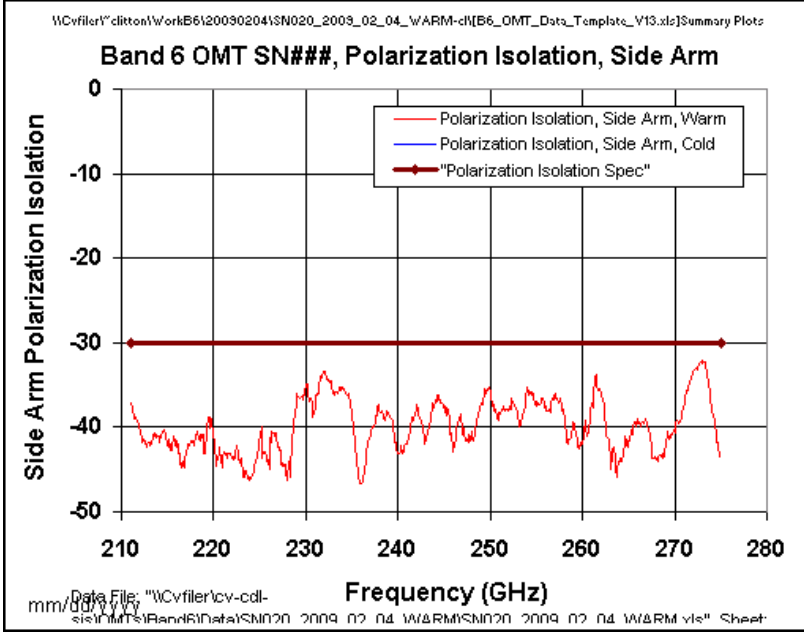
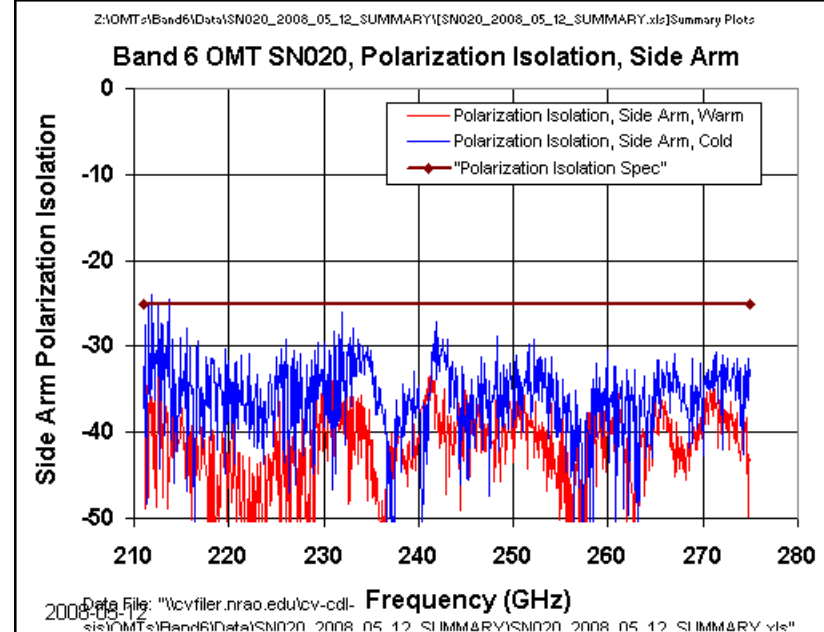
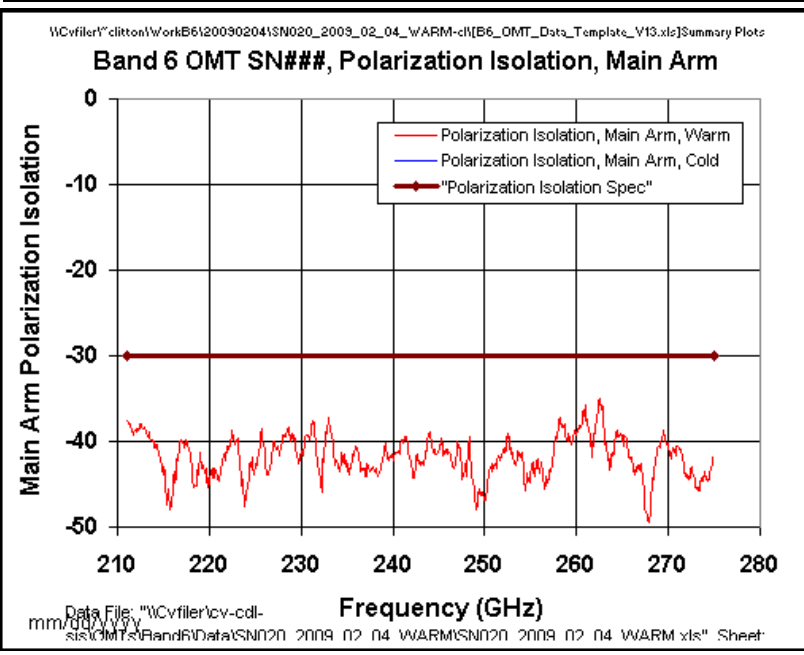
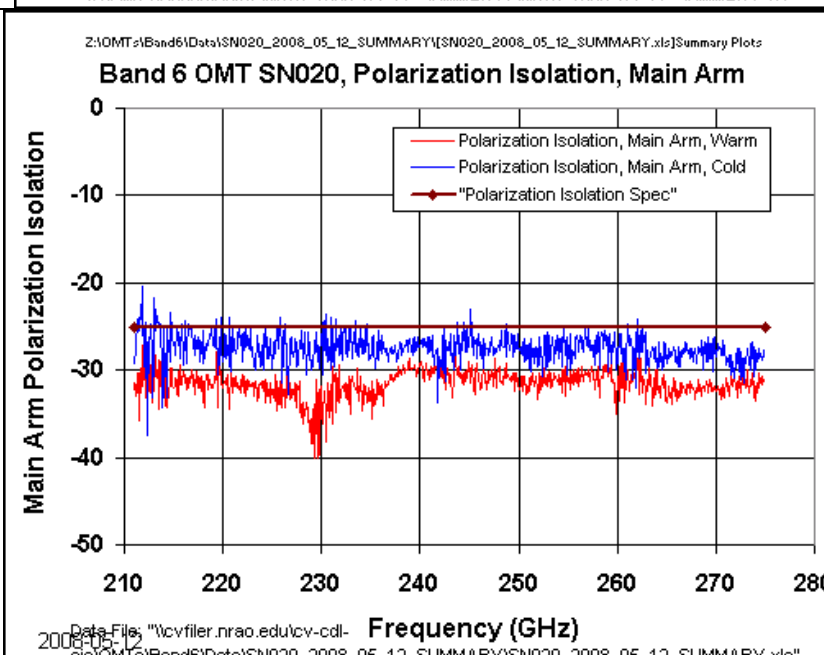
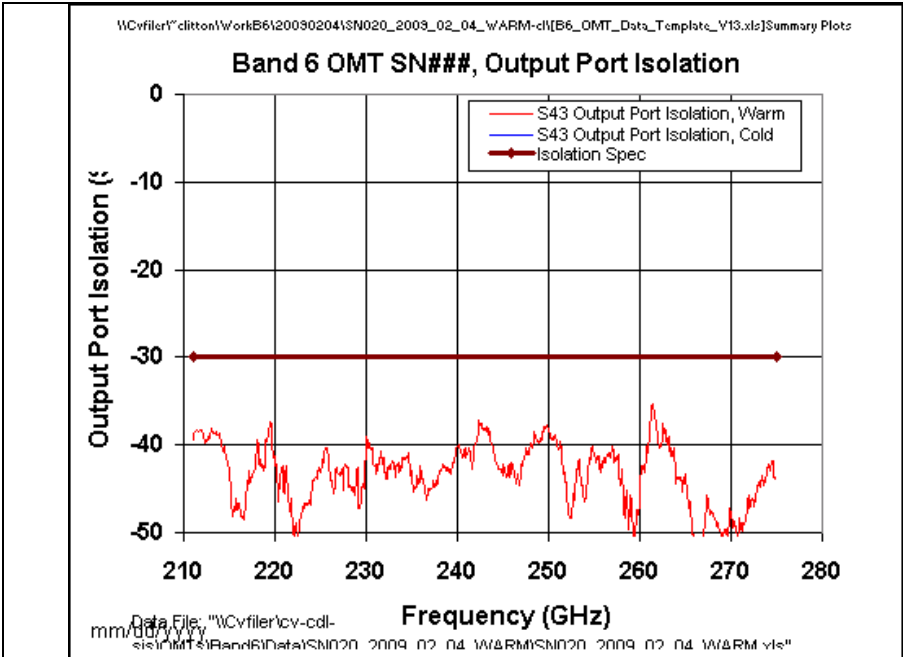
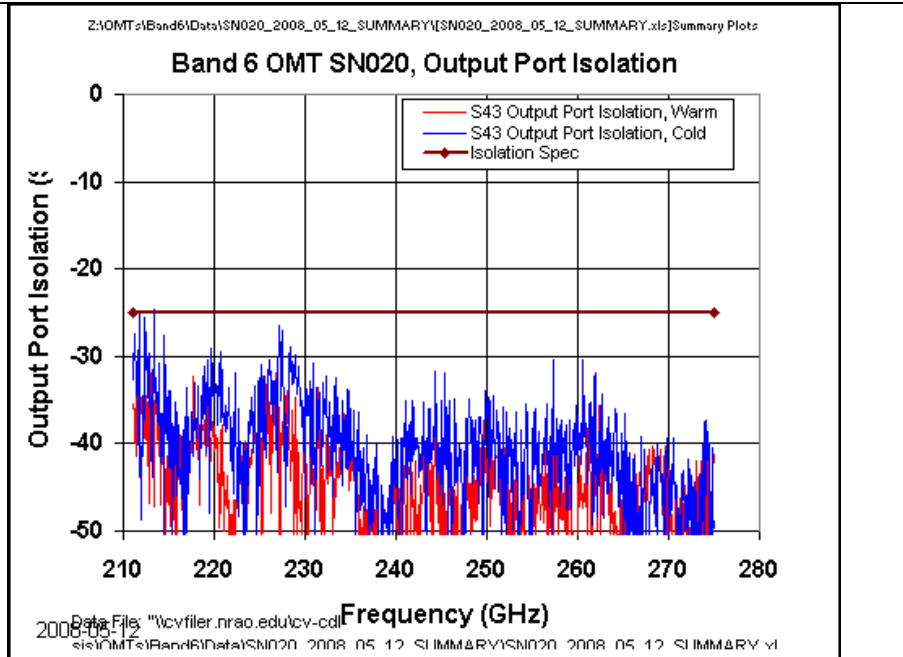
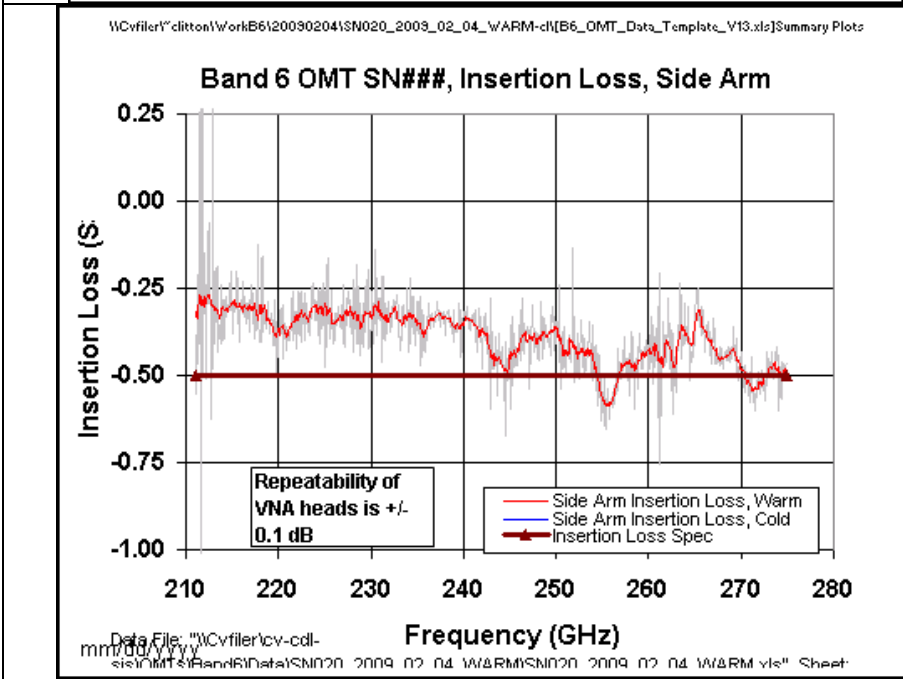
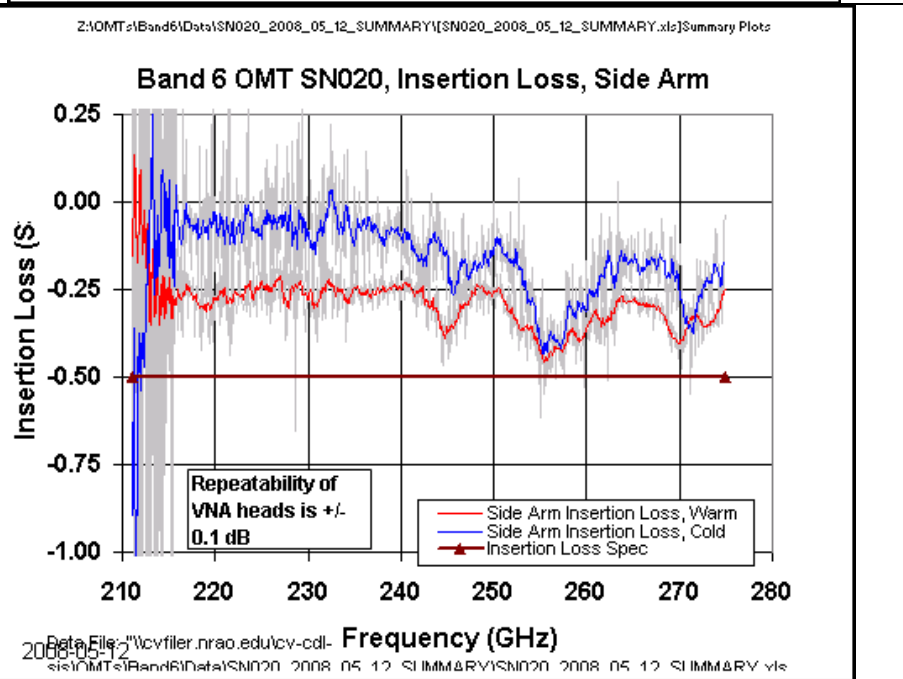
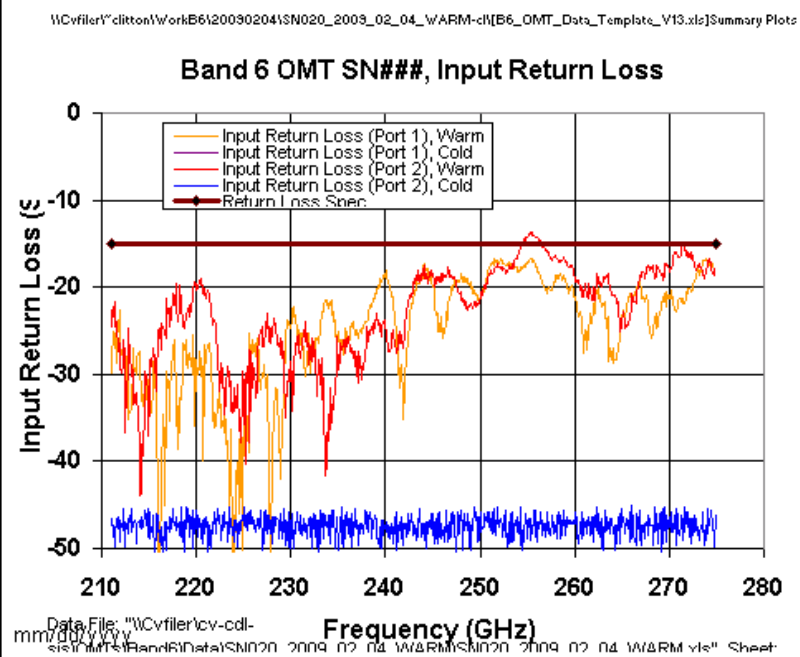
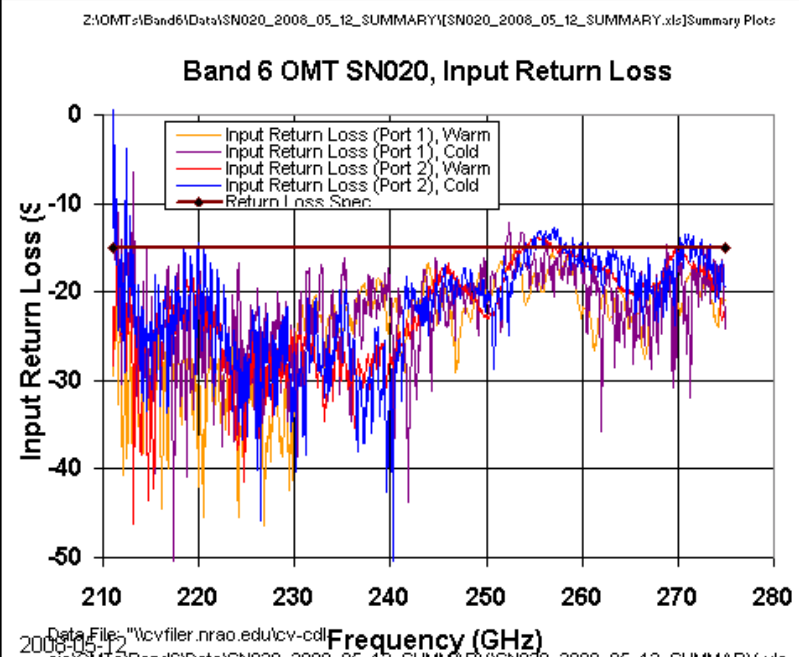
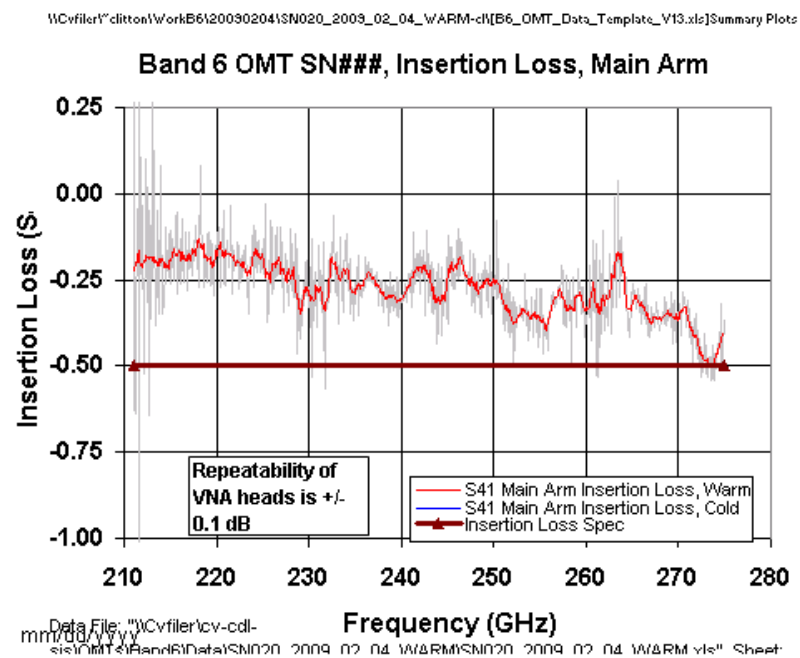
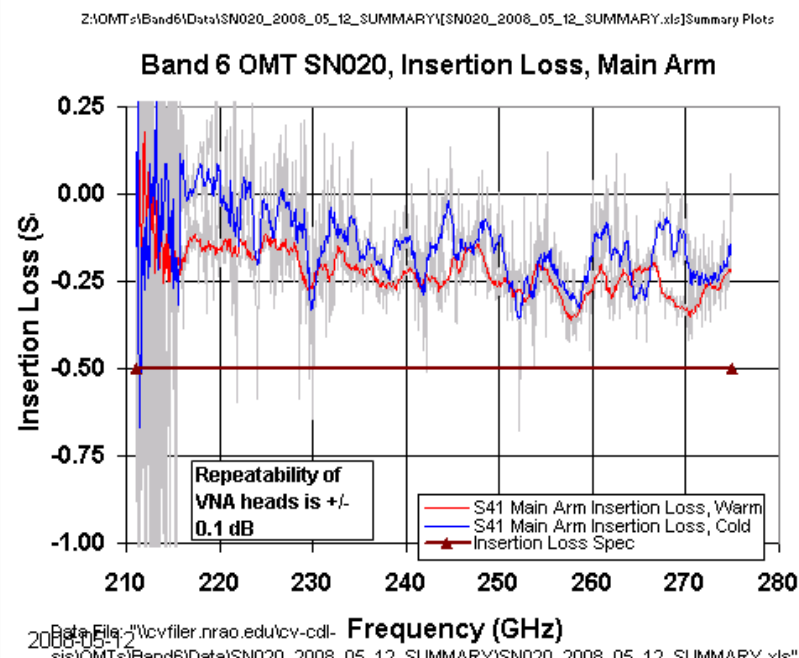
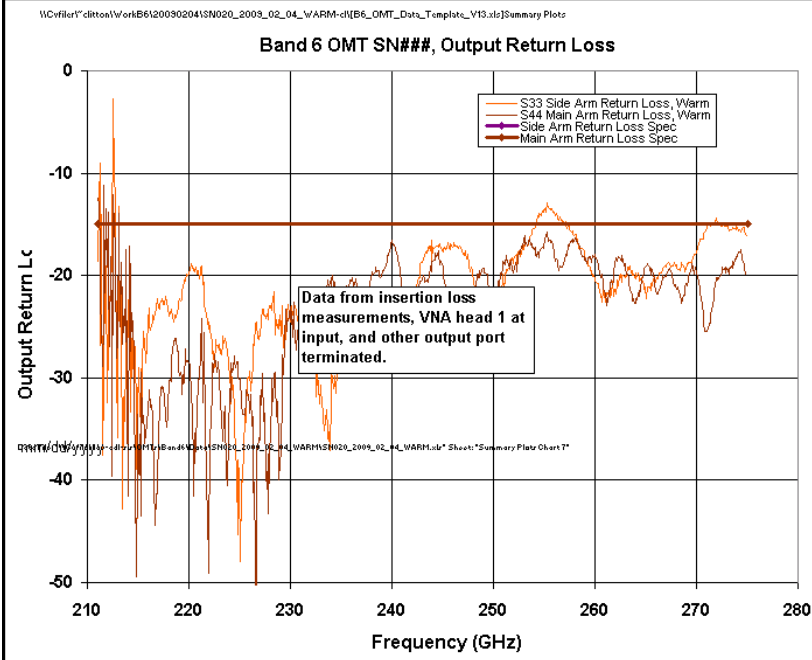
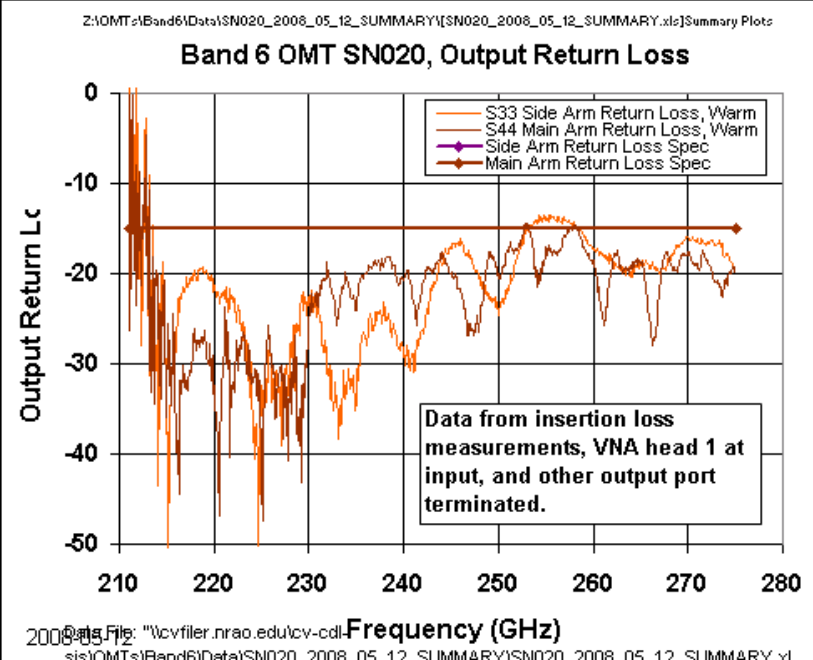
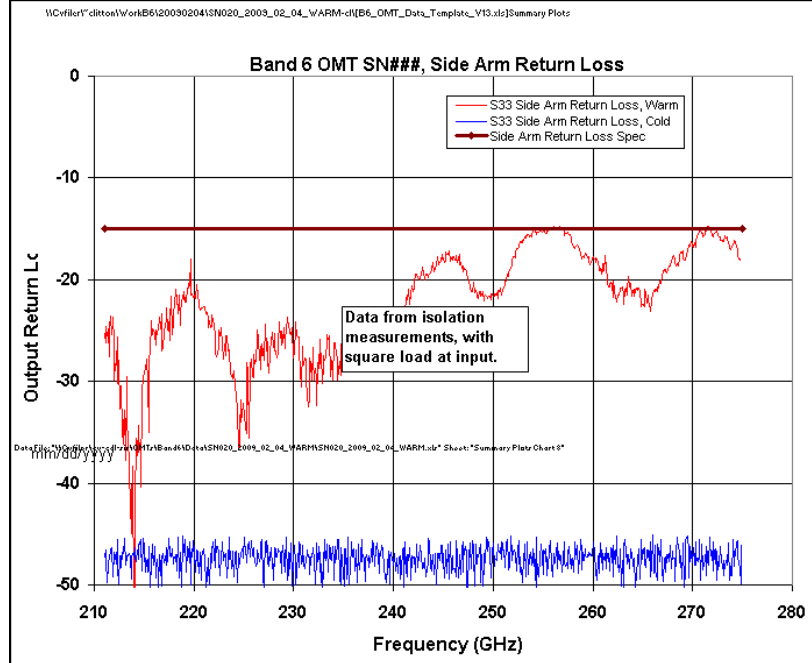
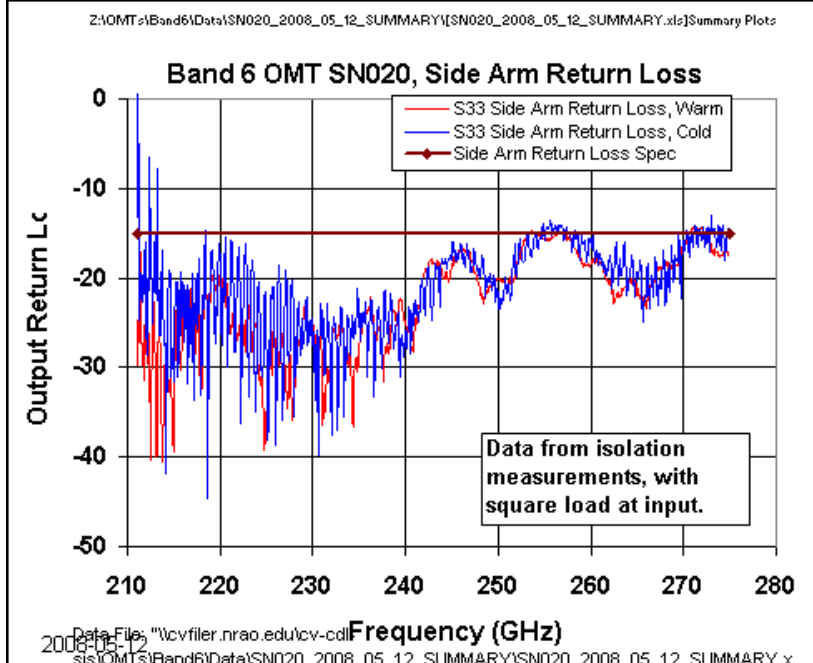
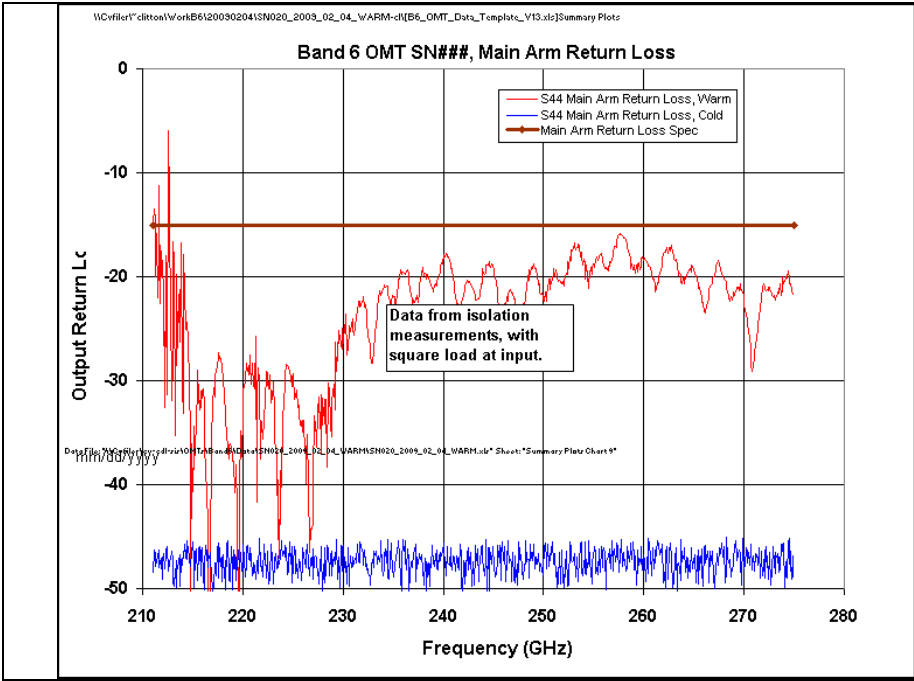
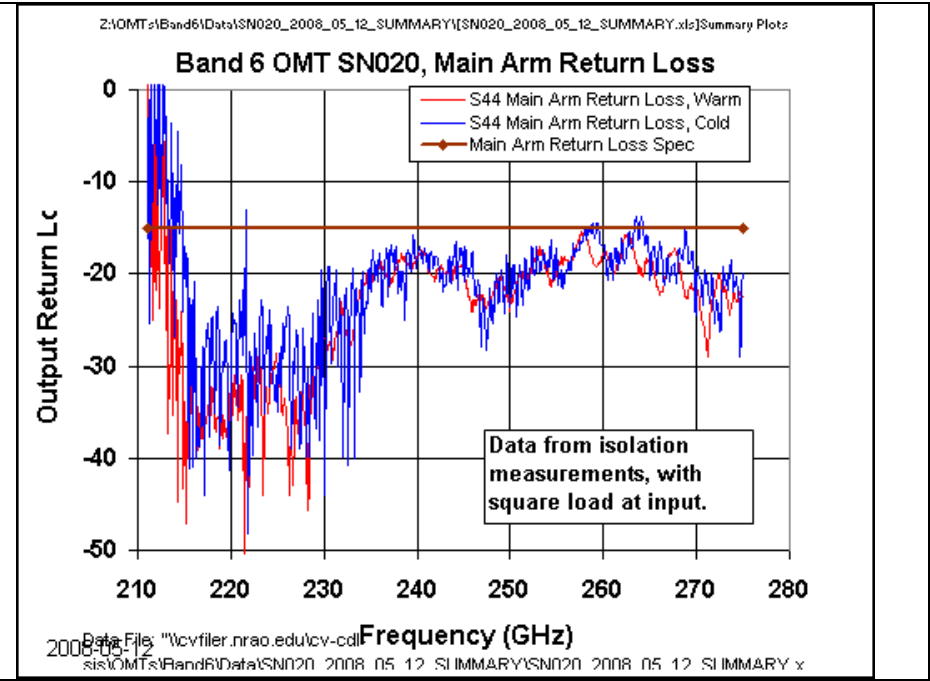
Figure 1: OMT6-020 Measured in Feb 2009 (Left Column) and May 2008 (Right Column)

Nevertheless, comparing OMT measurements before and after the drop shows surprisingly little change, as shown in Figure 1 below. In that figure, today's measurements are in the left column and the measurements in May 2008 are in the right column.

In particular, the cross-pol results seem to fall at the limits of the measurement, so the cause of cross-pol differences in the cartridge measurements remains unknown.

We have discovered that, indeed OMT6-020 was dropped about 50 cm (20") as part of the horn-OMT-mixer-preamp assembly during installation of that assembly onto the A-Frame. It's possible that the components were loosely bolted when dropped, so it's likely that damage to the OMT alignment pin hole occurred then.
